Learning from Earthquakes

The Great Sumatra Earthquake and Indian Ocean Tsunami of December 26, 2004

Report #3

The Effects in Mainland India and in the Andaman-Nicobar Islands

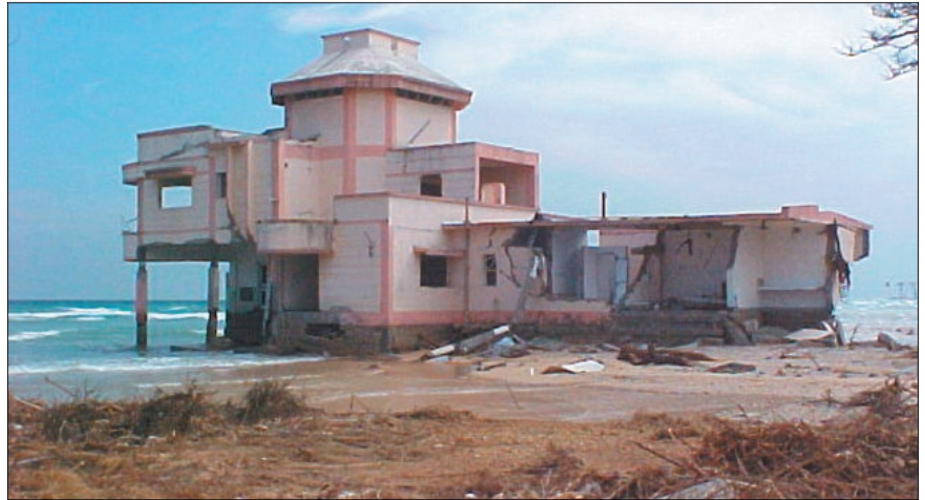
Figure 3. RC frame building (MES Inspection Bungalow) now stands in water on the eastern coast of Car Nicobar Island (photo: C.V.R. Murty).

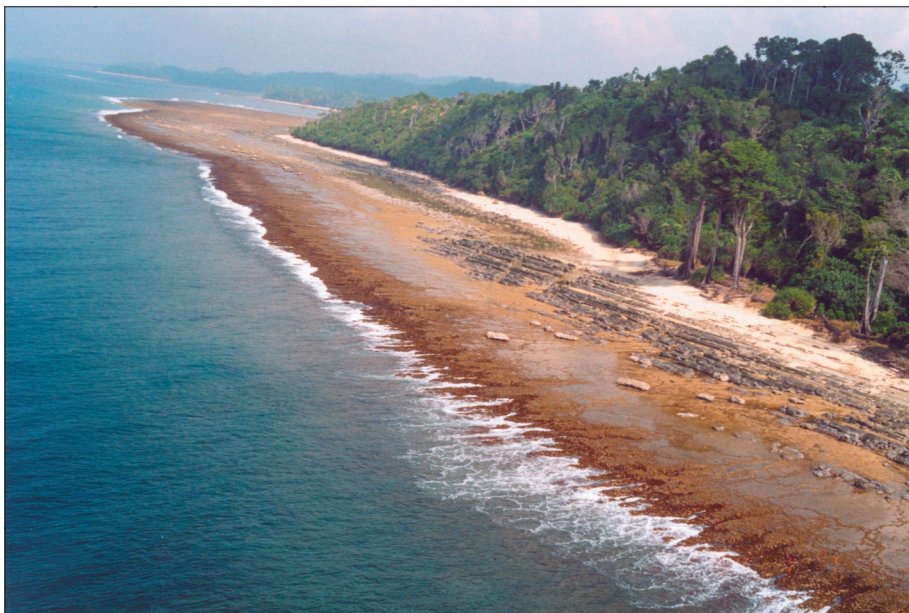
Island, suggesting an uplift of up to 0.3 m (Figure 4). The increased exposure of the RC piles at the jetty structure at Diglipur Harbor at the northern region of North Andaman Island (the northernmost of the A&N Islands) indicates an uplift of about 1.2 m.

Figure 4. Up-throw of coral beds and rock strata due to uplift on the western coast of Middle Andaman Island near Flat Island (photo: Javed N. Malik).

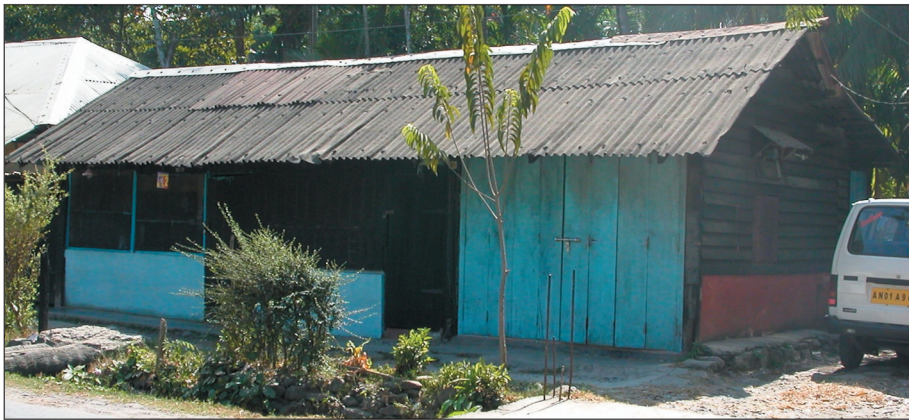
Figure 5a.
Single-story wood house in Port Blair with light roof had no damage (photo: C.V.R. Murty).

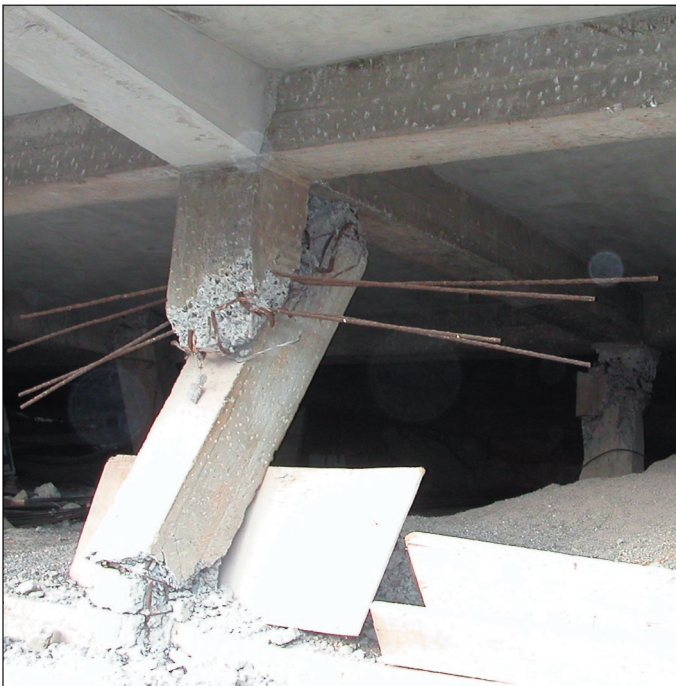
Building Damage: While damage in Little Andaman Island and all Nicobar Islands was predominantly tsunami-related, that in the islands north of Little Andaman was primarily due to earthquake shaking, though tsunami waves and high tides were also an issue. In general, the building stock consists of a large number of traditional and nonengineered structures. Many traditional structures are made of wood, and they performed well in the earthquake shaking (Figure 5a). However, a number of new, poorly constructed reinforced concrete (RC) structures suffered severe damage or even collapse due to shaking (Figure 5b).

Figure 5b.
A three-story RC frame building in the same town collapsed in a brittle manner (photo: Sudhir Jain).

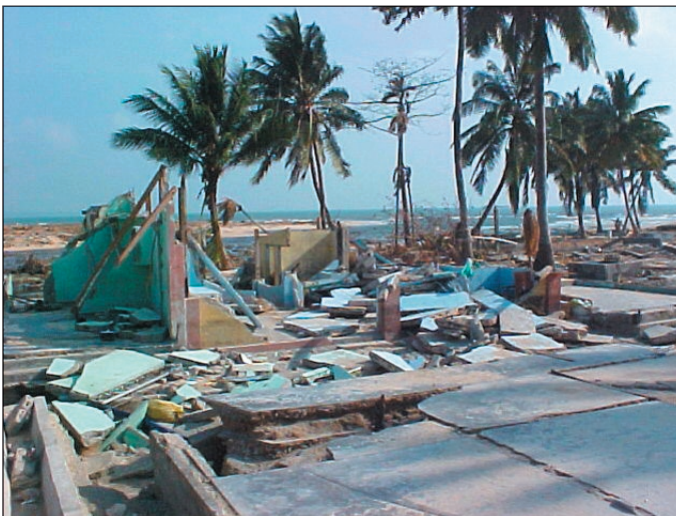
The tsunami waves caused severe destruction in the coastal areas of the southern islands (Figure 6). Structures near the water were subjected to (1) a positive water pressure when the waves arrived, and (2) a suction pressure when the waves receded. A large number of buildings right on the water in Little Andaman and Car Nicobar islands were washed away, regardless of how they were constructed.

Figure 6. *General destruction of built environment at Hut Bay in Little Andaman Island (photo: C.V.R. Murty).*

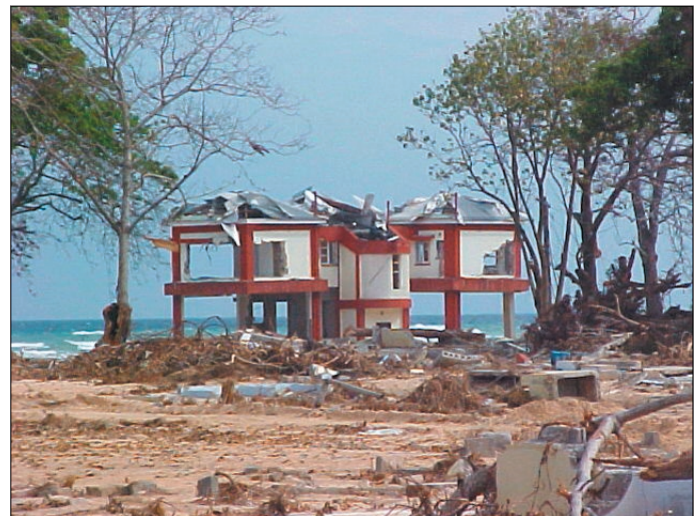
Figure 7. *Shore-front building on Car Nicobar Island was inundated by the waves, but the frame resisted the wave effects (photo: C.V.R. Murty).*

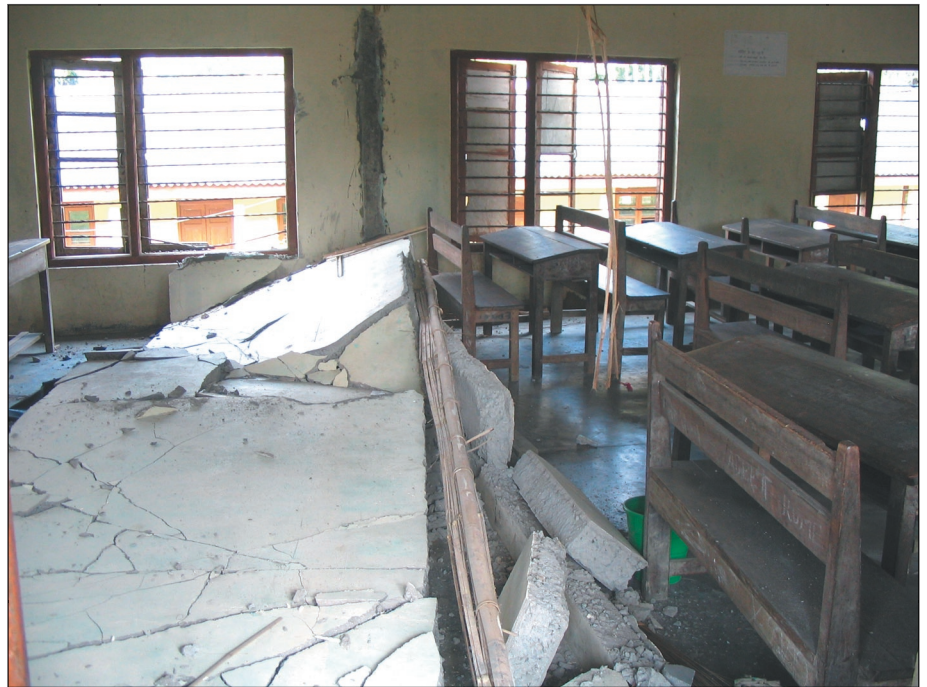
movement of the flexible roofs from earthquake forces caused out-of-plane masonry wall collapse. Similar damage was observed at a much larger scale in many school buildings, where the long partition walls separating two classrooms were either badly damaged or had fallen due to out-of-plane instability (Figure 8).

Figure 8. Slender masonry walls dislodged due to out-of-plane instability and poor or no connection to the surrounding structural elements (photo: Durgesh C. Rai).

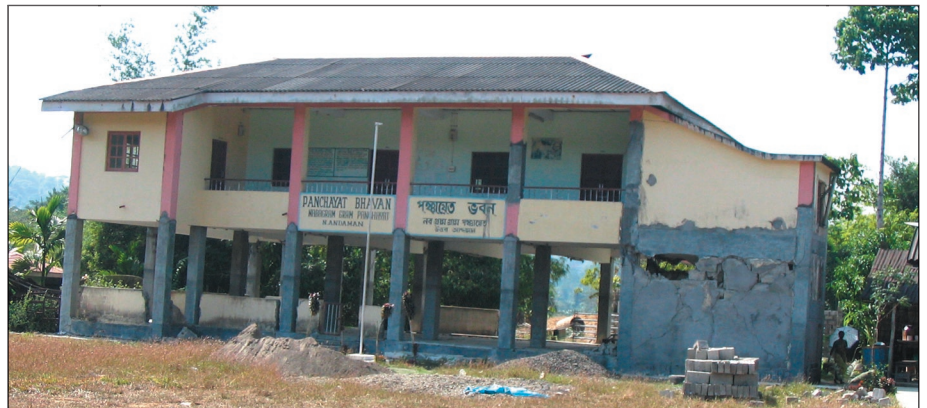
Figure 9a. The Panchayat Bhavan building showed severe cracking and damage to the soft first-story columns and infill walls (photo: Durgesh C. Rai).

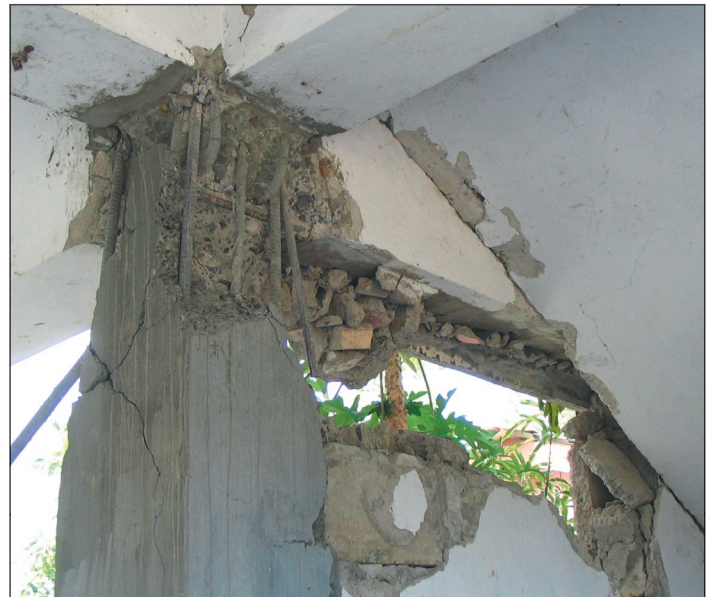
Figure 9b. Detail of column failure in the ground story (photo: Durgesh C. Rai).

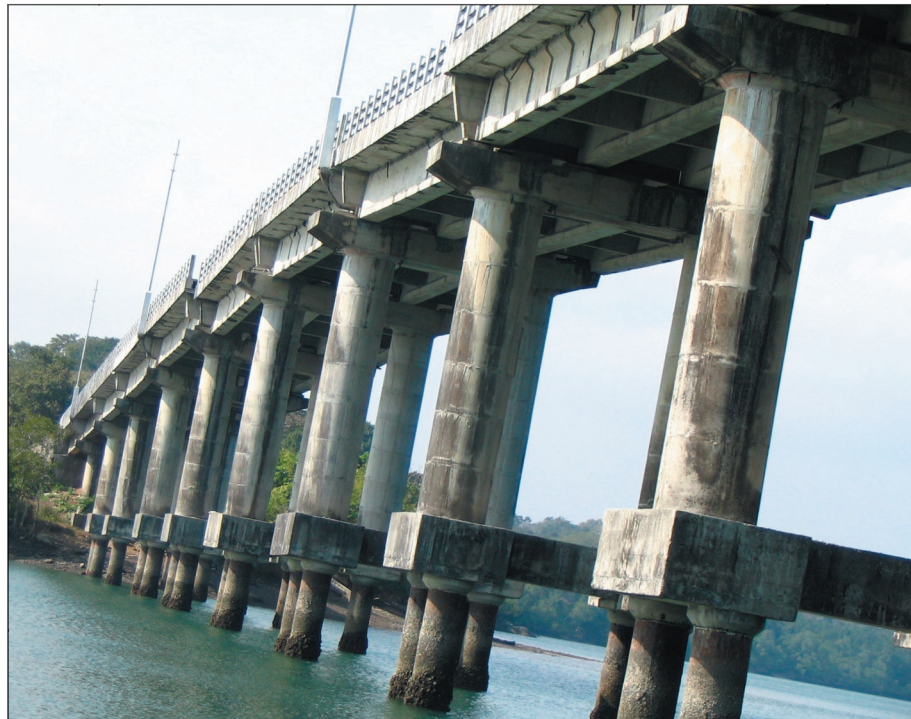
Damage to Infrastructure: A newly constructed 268 m-long RC bridge over the Austen Strait, connecting the North and Middle Andaman Islands on the Andaman Trunk Road, had to be closed to even light vehicles. Three middle spans of the superstructure were displaced laterally by about 70 cm and vertically by about 22 cm and fell off the bearing (Figure 10). Some other spans were also

Figure 10a. Chengappa Bridge over Austen Strait was rendered dysfunctional by displacement of the middle spans (photo: Durgesh C. Rai).

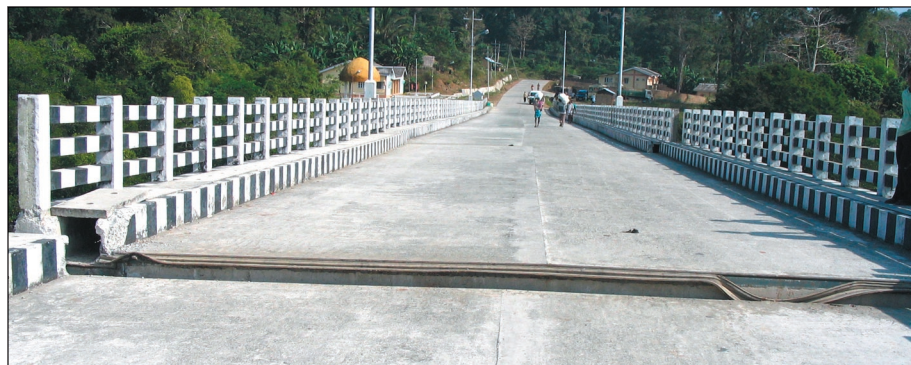
“Inadequate seating of bridge deck over piers and abutments is a serious concern for its safety during a stronger earthquake in the future. The bearings are simple neoprene pads which are far from satisfactory for a bridge located in seismic

zone V. Bridge deck restrainers are the minimum that need to be provided to ensure that the spans are not dislodged from the piers in future earthquakes.”

Figure 10b. Detail of the bridge deck showing lateral and vertical displacement due to shifting of the decks on their neoprene bearings (photo: Durgesh C. Rai).

- d) Bridges in the coastal areas need to have lateral restraints to prevent the loss of spans during the buoyant conditions developed under high-tide levels.

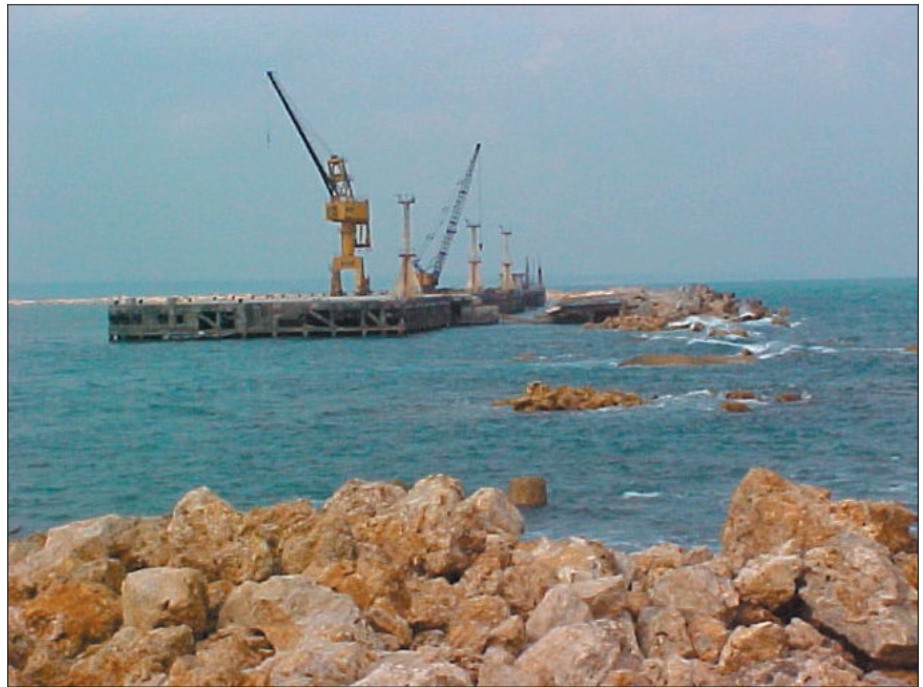
Figure 11. Shortage of appropriate construction material forced the use of porous coral stones from local quarries for building the breakwaters. The stones were easily uplifted during the tsunami and breached a large segment of the approach to the RC jetty at Hut Bay (photo: C.V.R Murty).

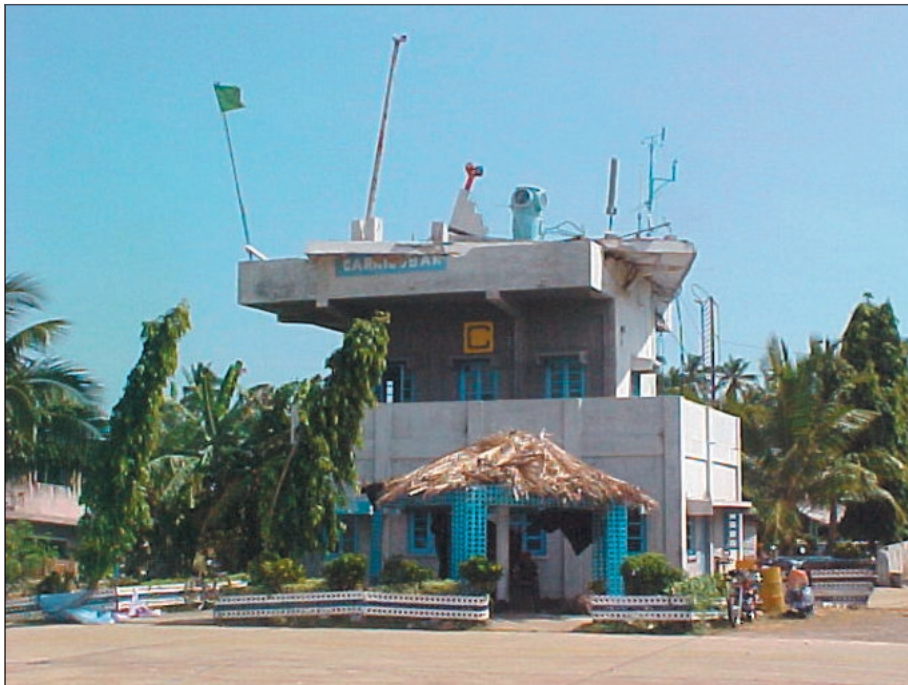
Other facilities like hospitals and seaport/airport control towers collapsed due to shaking and/or wave pressure. The airport control tower at Car Nicobar is a three-story RC frame with masonry infills, and its upper story collapsed in the shaking (Figure 12a). The seaport control tower at Hut Bay on the east coast of Little Andaman Island also collapsed due to the tsunami waves (Figure 12b). This square-plan three-story RC frame building with masonry infills had only four-corner columns and, hence, limited redundancy. The large positive pressure created by the tsunami waves toppled the building. Similar tower designs are being used elsewhere in the country, particularly in the seismic zones, so there is an urgent need for corrective action to strengthen them.

Figure 12a. Partial-collapse of the upper story of the air traffic control tower at airport on Car Nicobar Island (photo: C.V.R. Murty).

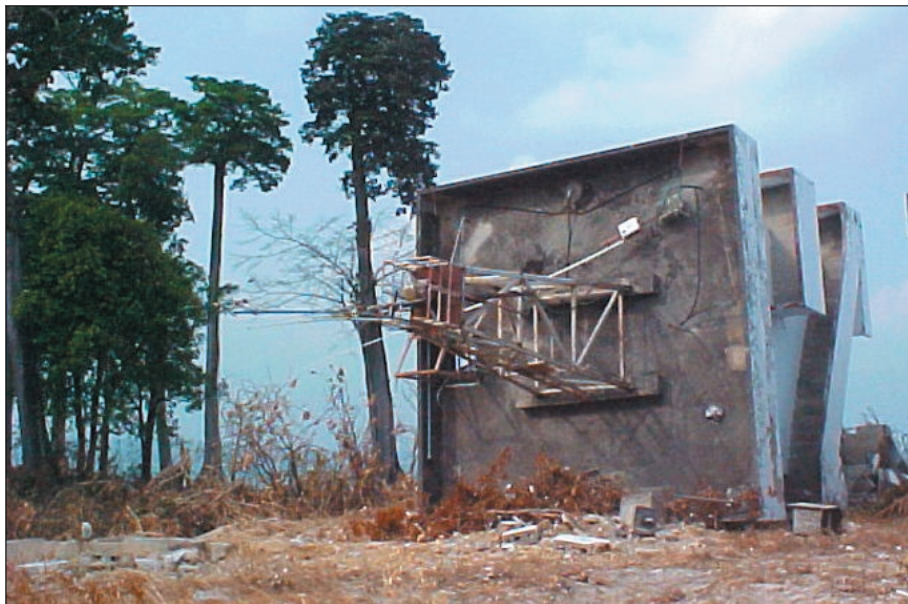
Figure 12b. Laterally toppled three-story seaport traffic control tower at Hut Bay in Little Andaman Island (photo: Suresh R. Dash).

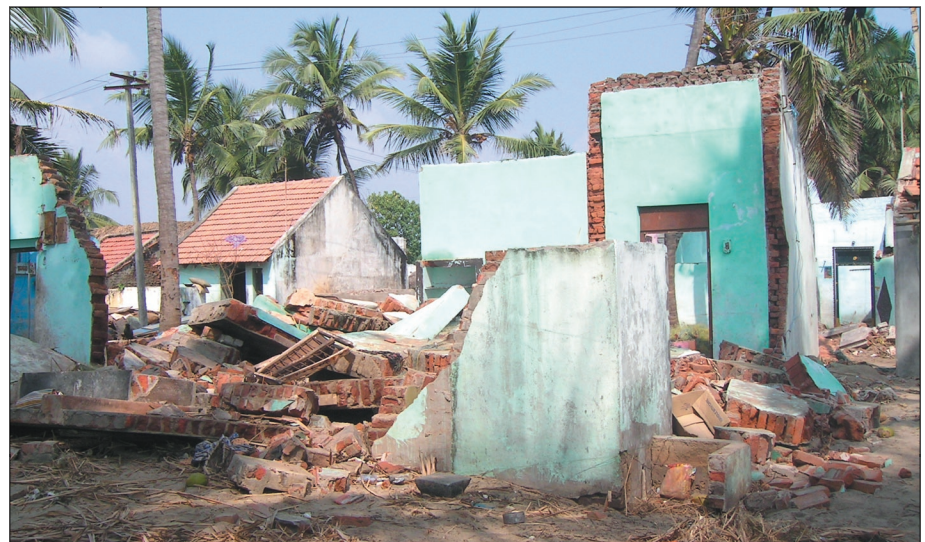
Figure 14. Houses destroyed by the waves at Nagapattinam in Tamil Nadu (photo: Alpa R. Sheth).

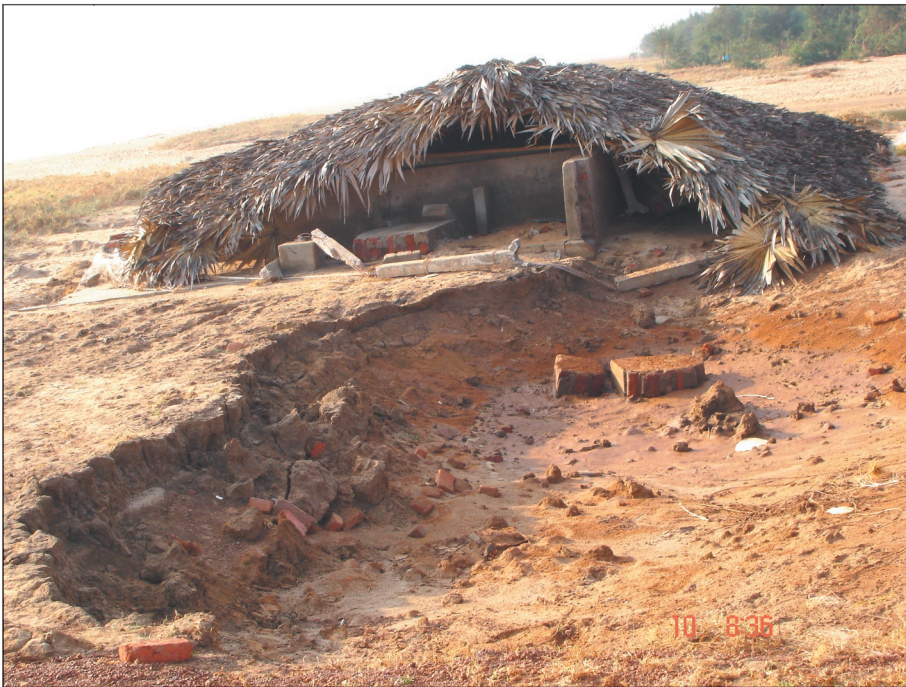
Figure 15. Mud house with thatch roof built within 100 meters of the sea at Pakala Beach in Andhra Pradesh (photo: Arvind Jaiswal).

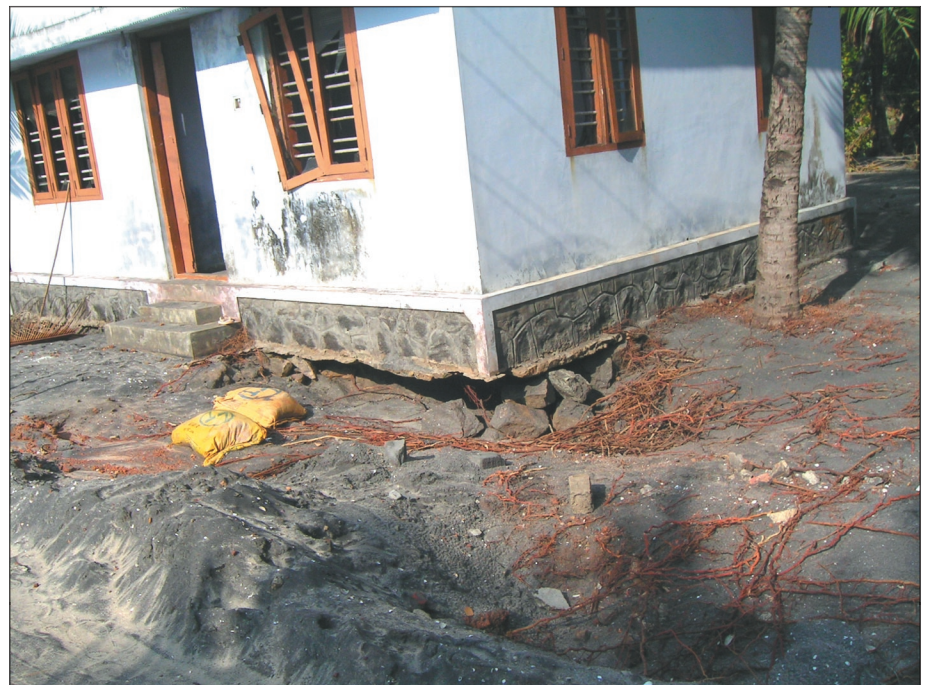
Figure 16. Scouring action at the base of houses due to returning wave of the tsunami in Kollam district in Kerala (photo: Alpa R. Sheth).

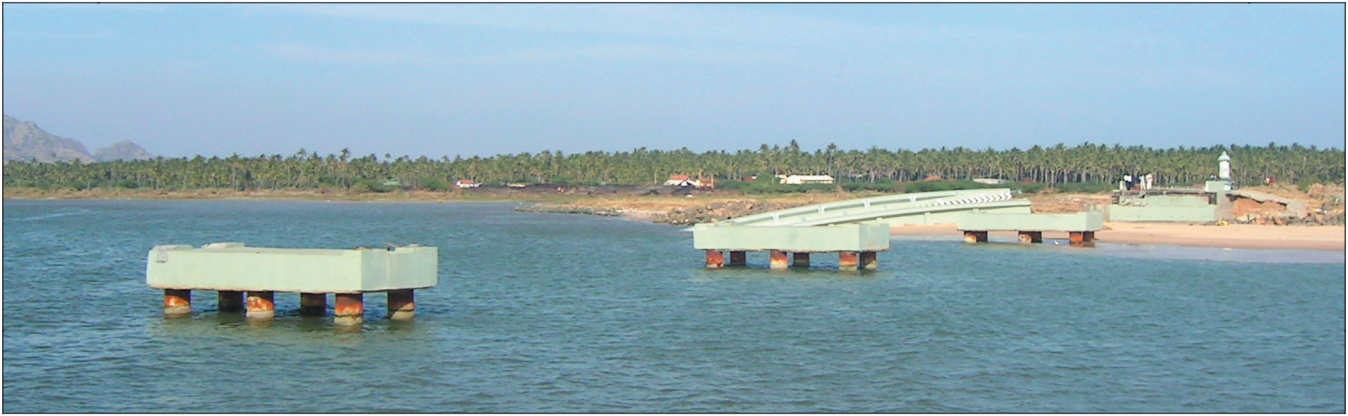
Bridges and culverts were affected. At least three bridges were damaged, with one of them losing all four spans (Figure 17). Roads suffered significant scouring at numerous places along the coast, as did railway lines. Road embankments were eroded. Compound walls

Figure 17. Complete loss of spans of the four span RC bridge at Melmannakudi in Tamil Nadu (photo: Alpa R. Sheth).
