# On Better Engineering Preparedness: Lessons from the 1988 Bihar Earthquake

Earthquake Spectra, EERI, Vol.8, No.3, 1992

*Sudhir K. Jain*

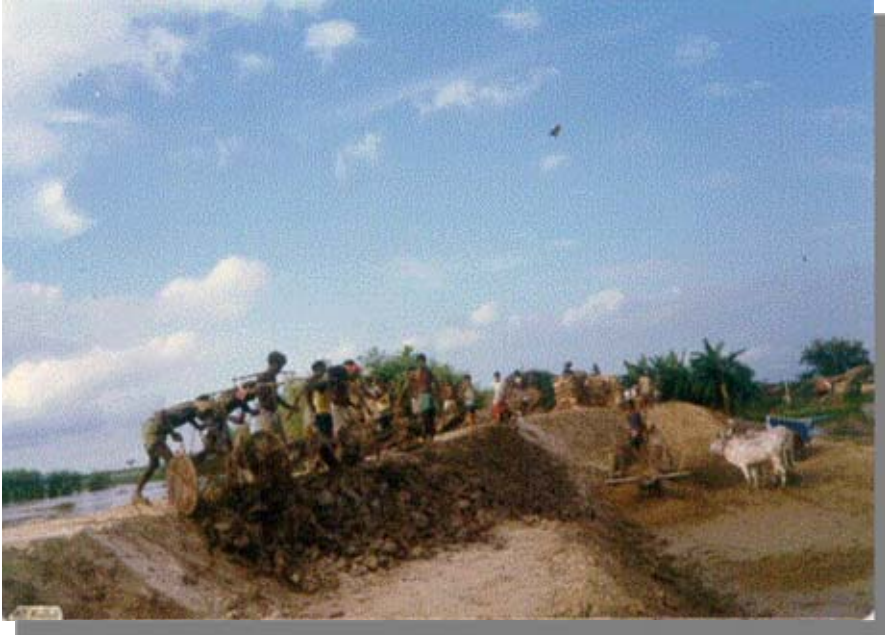
*Figure 2: Restoration of a subsided embankment without any compaction*

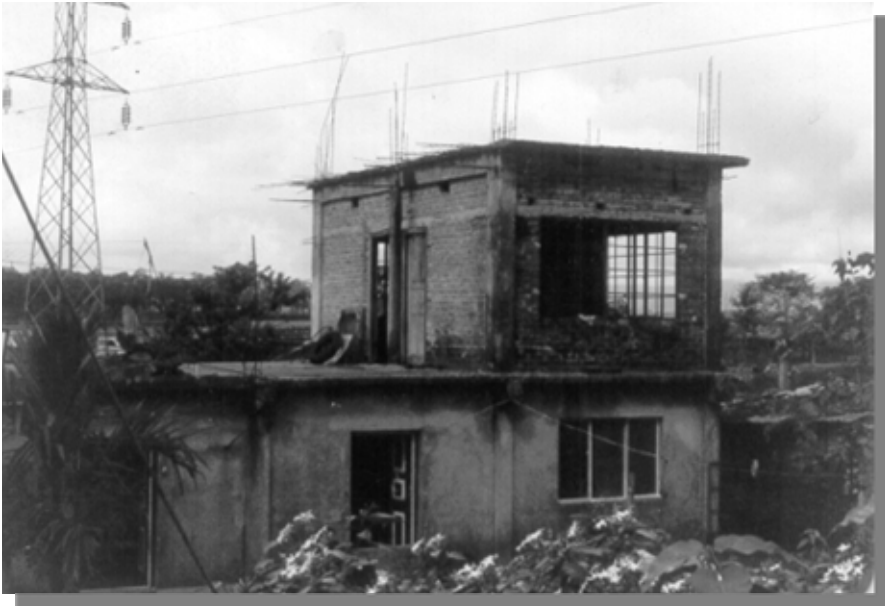
but the builders lack proper training and hence misunderstand the code provision of lintel band in masonry load bearing construction as noted by it being applied to filler walls in frame buildings.

*Figure 3: R.C. Frame Building in Siliguri with 'Lintel Band'*
