Background

The Earthquake

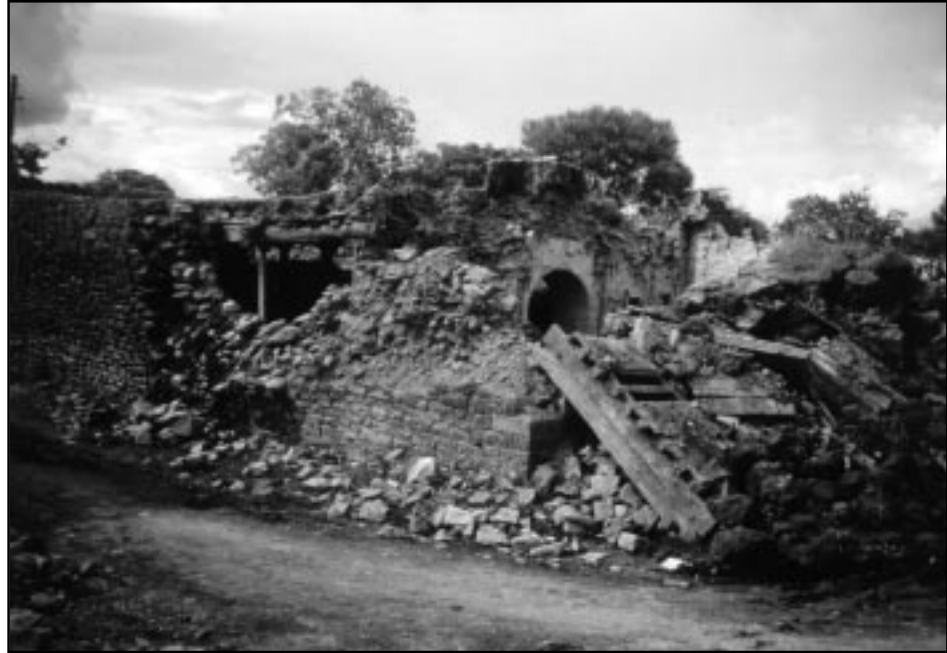
Figure 2 A typical stone masonry and mud mortar building in complete ruins after the earthquake.

damaged dwellings were nonengineered, stone masonry structures (Figure 2).

The inferior quality of construction and the degradation in stone masonry construction practices were among the underlying reasons for the vulnerable housing stock and the resulting extensive damage (Momin, Nikolic'-Brzev, and Bajoria, 1996). Results of the damage assessment revealed that most of the fatalities reported were due to the failure of stone masonry walls and/or the collapse of heavy earthen roofs supported by the stone walls. It is worth noting that the presence of timber frames (“khands”) saved many lives. After the earthquake, in many of the devastated villages it was common to find an intact pavilion of timber frames with roofs standing in a mass of rubble (Figure 3).

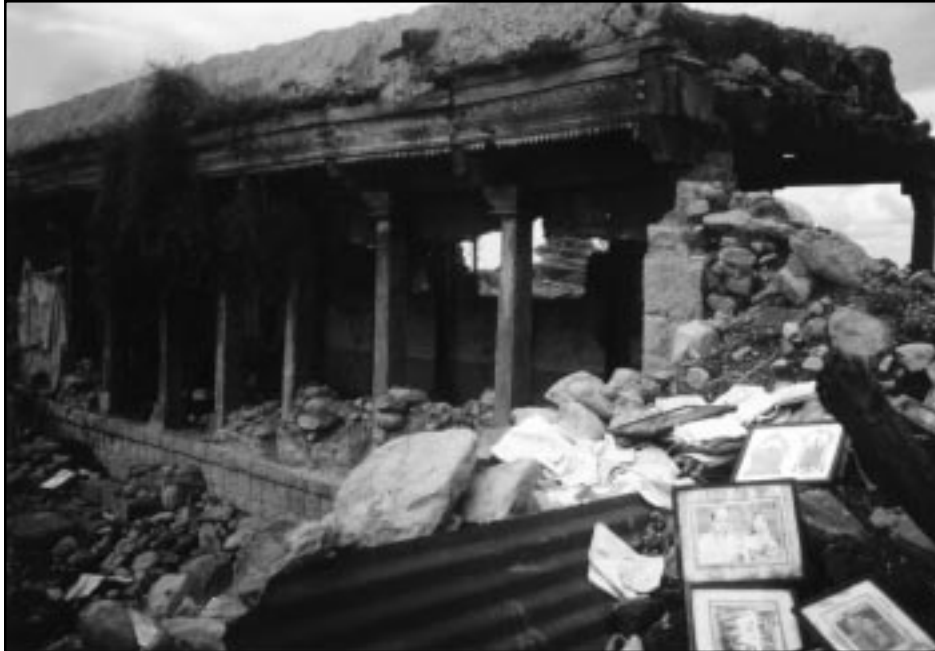
Figure 3 A typical timber frame with mud overlay in Killari village. The frame withstood the earthquake, but the walls collapsed.

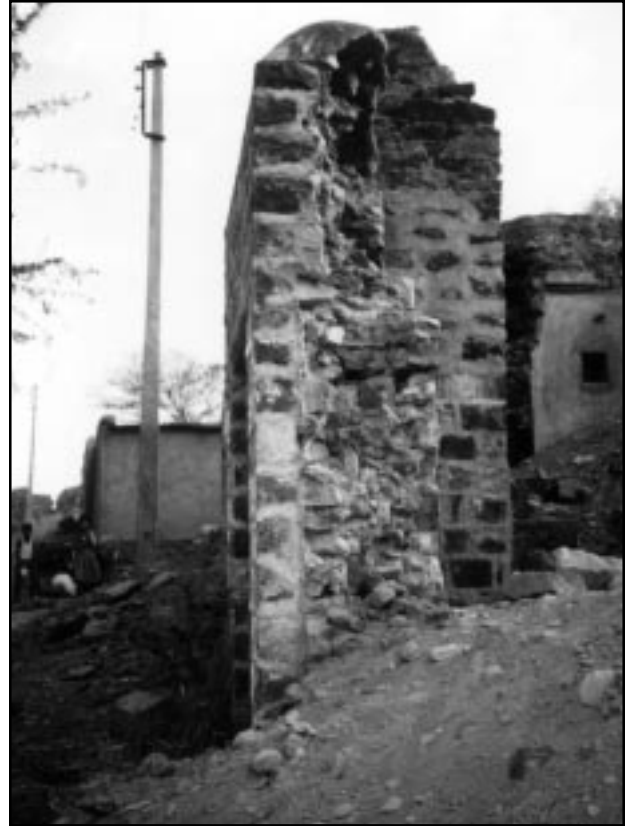
The majority of traditional dwellings in low rainfall areas (Marathwada and Solapur districts) are single-story buildings consisting of several small rooms with small door openings and no window openings. Stone, a durable and abundantly available material, has been used for wall construction in the Marathwada region for centuries. For the sake of thermal comfort during the hot summer months (when peak temperatures exceed 40° C [104° F]), extremely thick stone walls (ranging from 500 mm to 2 m [1 ft. 8 in. to 6 ft. 7 in.] thick) are common (Figure 5).

Figure 5 A typical stone wall with two exterior wythes and interior filled with rubble and mud (wall thickness over one meter).
