# Housing Reconstruction

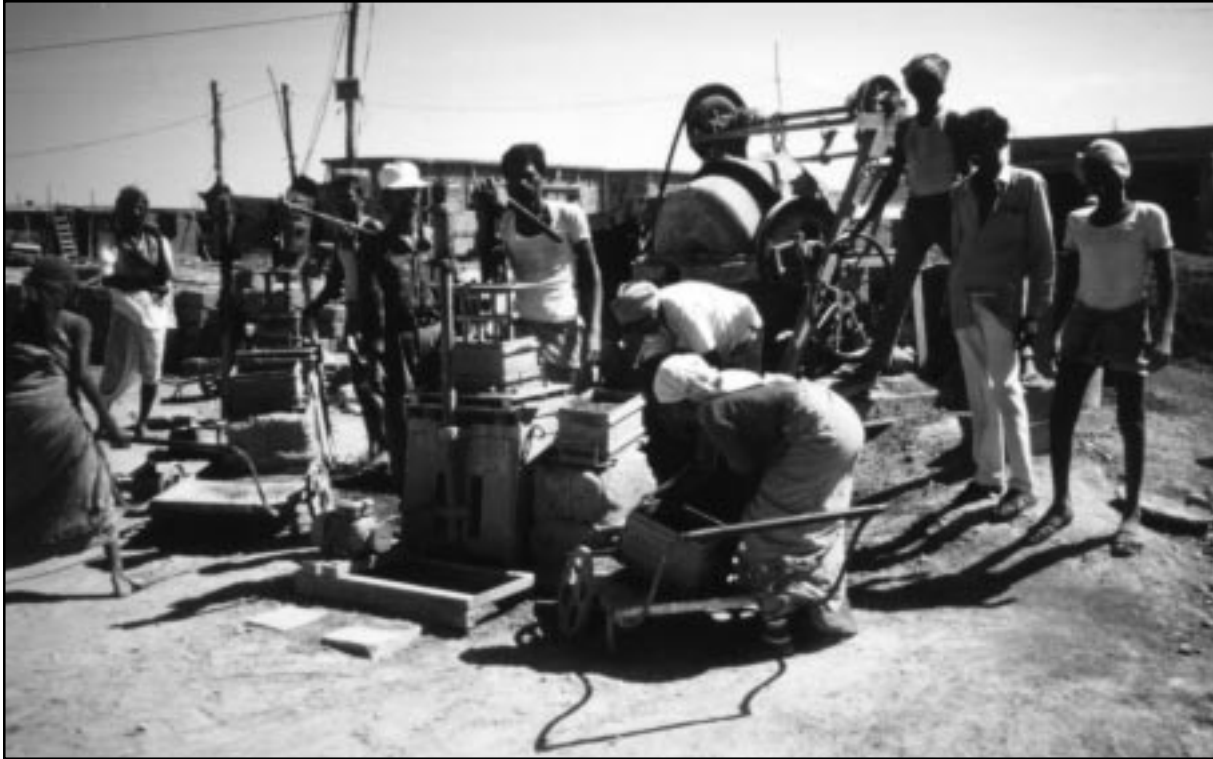
**Figure 9** Manufacturing of concrete blocks by a contractor using a block-making machine in a relocation village.

relocation and the limited number of local artisans available for construction. Different contractors were selected for each of the relocation villages and were then responsible for all the construction in the village. These contracts were managed by the Project Management Unit (PMU) created for this project. Engineering consultants and rural resettlement planners carried out village planning and design and supervised the contractors who did the construction (Figure 9).

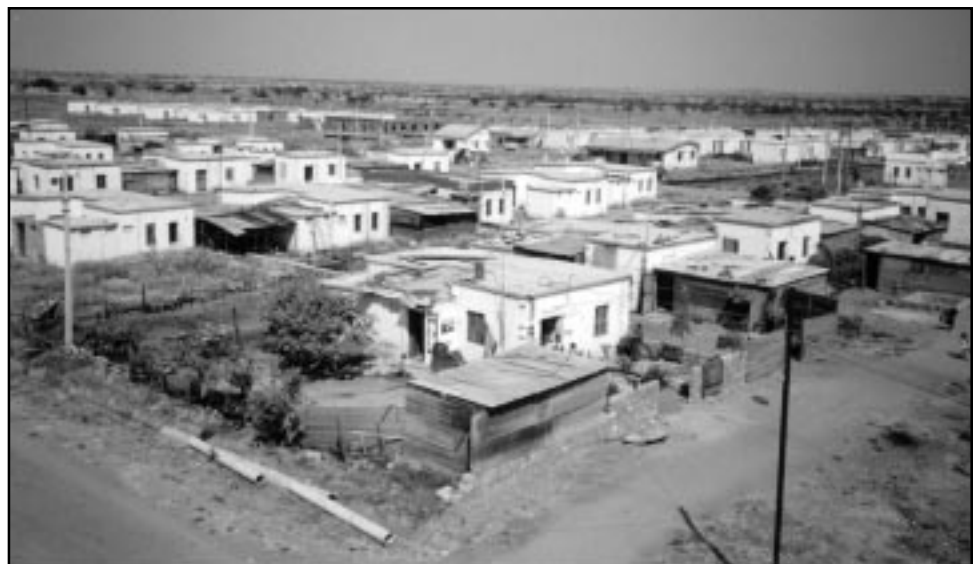
**Figure 10** A grid-like layout of a relocation village, Latur district

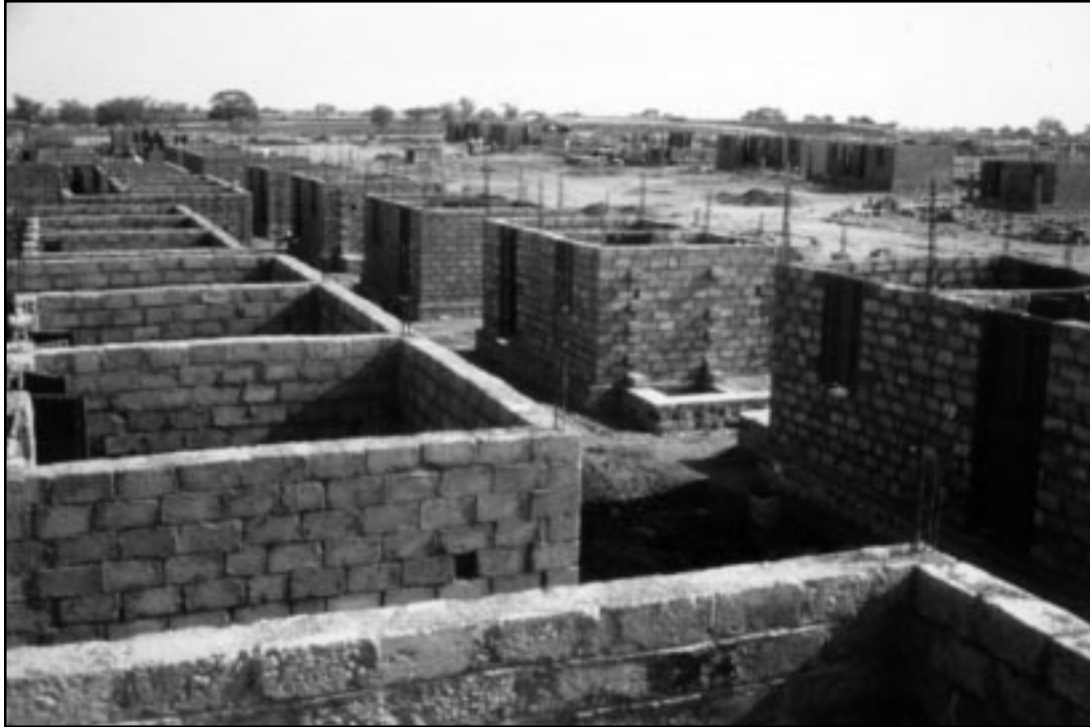
**Figure 12** Vertical reinforcement bars were provided in concrete block wall construction (Killari village, Latur district).

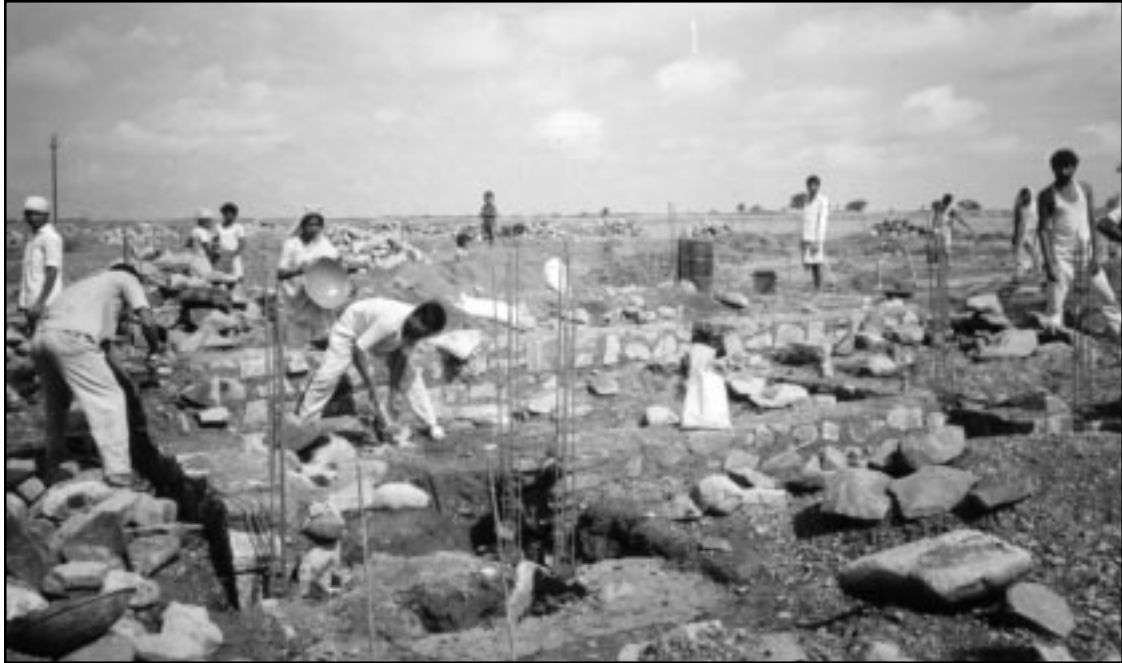
**Figure 13** Construction of building foundations in Killari village. Stone masonry was used up to the plinth level.

(200 mm [8 in.] thick) that appeared to be acceptable to the affected communities. Due to the villagers' immense fear of stone construction in the aftermath of the earthquake, stone boulders were used only for the construction of strip foundations (up to the plinth level) (Figure 13).

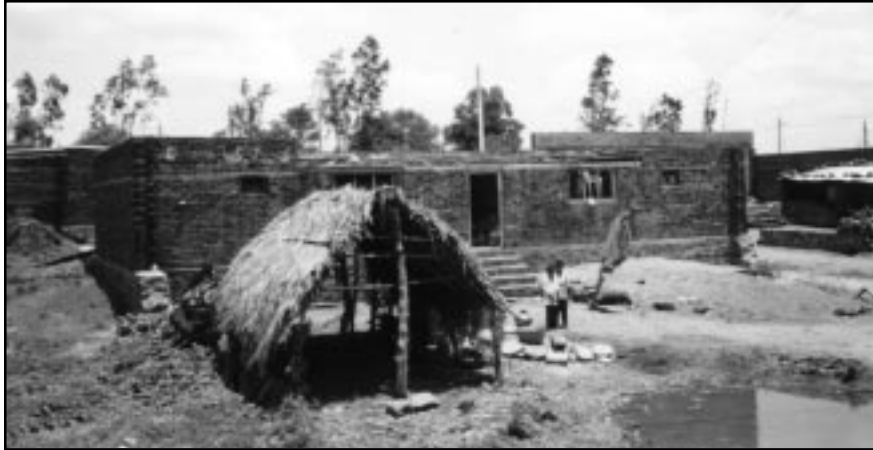
**Figure 14** A house in the new Jawli village constructed by the beneficiaries. A larger built-in area was obtained within the same financial package for this owner-managed project. Huts similar to that shown in the foreground were made by beneficiaries who were afraid to stay in their houses, even though many houses were only moderately damaged.

The beneficiaries themselves constructed the remaining houses in the village (Figures 14 through 17). Each house was of a unique design, created by the beneficiary and his family. In most cases, the walls were constructed using brick masonry or, less often, stone masonry. Either concrete slab or corrugated galvanized iron (CGI) sheets were used in the roof construction. According to the rapid survey made by the authors, a considerably larger built-in house area was obtained in the case of owner-managed construction. In some cases, the beneficiaries were able to construct four rooms with approximately 450 sq. ft. of carpet area using the same financial package. In this example, community-managed construction appears to have been more cost-effective (by approximately 33 percent) than mass construction.

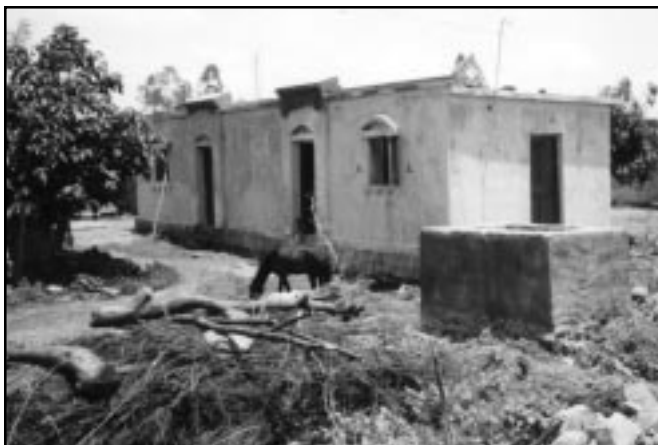
**Figure 15** (Left) Houses in the new Jawli village constructed by Caritas.

During a July 1998 field trip, the authors visited several of these hybrid villages (Krimgold and Nikolic-Brzev, 1998). The case of Jawli village in the Latur district appeared to be a particularly interesting one (Figures 16 through 19). Out of the 561 (100 percent) houses in total, 215 (38 percent) houses were constructed by an NGO (CARITAS), whereas the remaining 356 houses (62 percent) were constructed by the beneficiaries themselves (GOM, 1998c). The entire village was resettled at a new location approximately 3 km away from the original one. All the houses constructed by the NGO looked alike; a single-house plan with two rooms and approximately 250 sq. ft. of carpet area was used for the entire village. Solid concrete blocks were used in the wall construction, and a concrete slab was used in the roof construction. Strip foundations

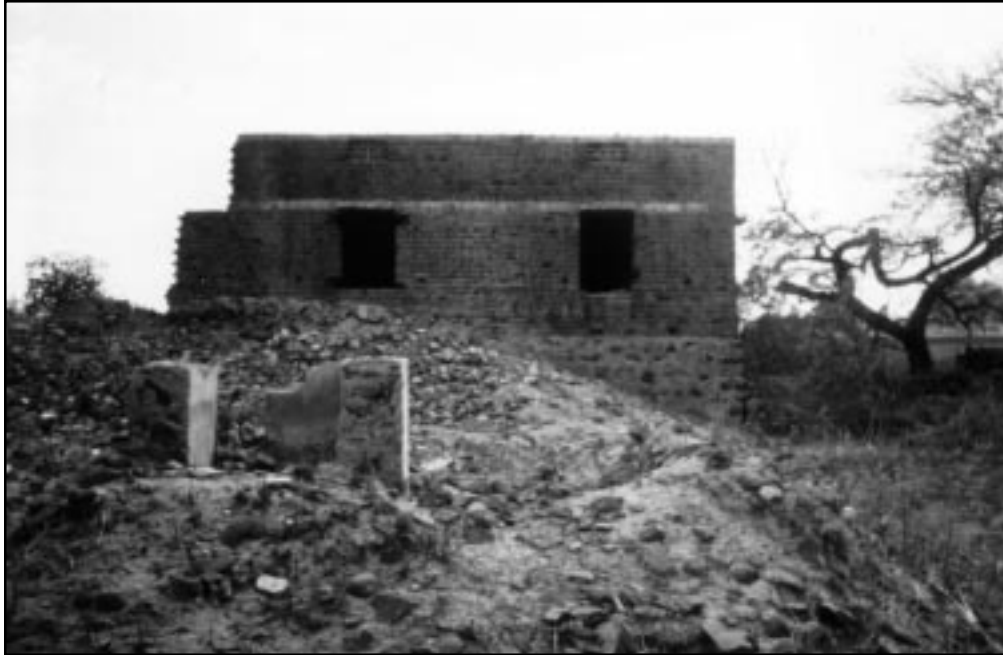
**Figure 18** An unreinforced masonry building constructed to the higher standards and with a concrete lintel band survived the 1993 earthquake without any damage (Killari village, Latur district).

damage to the structural and nonstructural elements, they did not collapse and thus fatalities were avoided. The lessons learned in this earthquake indicate that the required level of seismic safety can be achieved by using local construction materials and skills in an adequate manner and by following the minimum seismic requirements recommended by Indian seismic codes and standards (Figure 18).

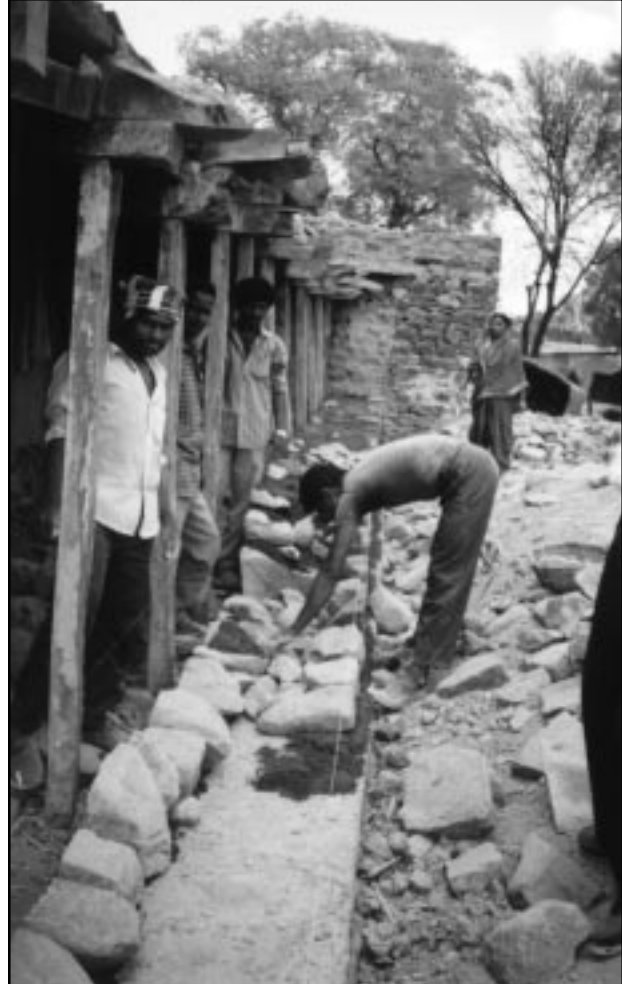
**Figure 19** The GOM recommended reconstruction on the same plinth. The existing timber structure was preserved, and the walls were reconstructed in the improved manner.

- Construction using the same foundations and plinth, starting with the plinth band construction was recommended (Figure 19).
- In case of UCR stone masonry construction, recycling of the stones dismantled from the existing house was recommended. Beneficiaries were given guidance regarding the selection and cleaning of adequately shaped stones (Figure 20).
- Maximum utilization of the existing construction elements, such as door and window frames, was recommended.
- Mandatory use of UCR stone masonry in an improved manner, with wall thickness restricted to 450 mm (1 ft. 6 in.), through-stones, corner stones, and shaped stone boulders. This was of utmost importance to ensure considerable improvement of the seismic safety of stone buildings in future earthquakes.

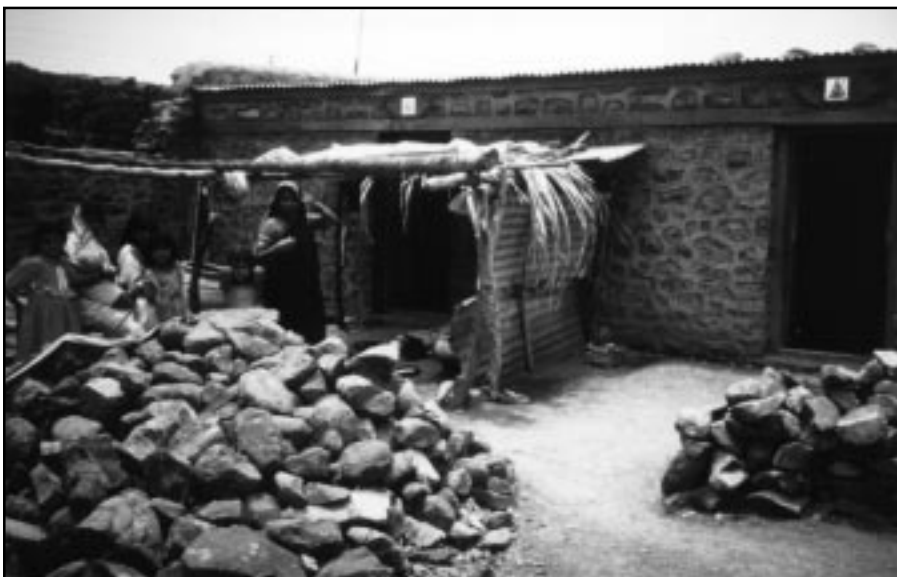
**Figure 20** A stone masonry house reconstructed in an improved manner. The round stone boulders dismantled from the original house were not used for the construction.

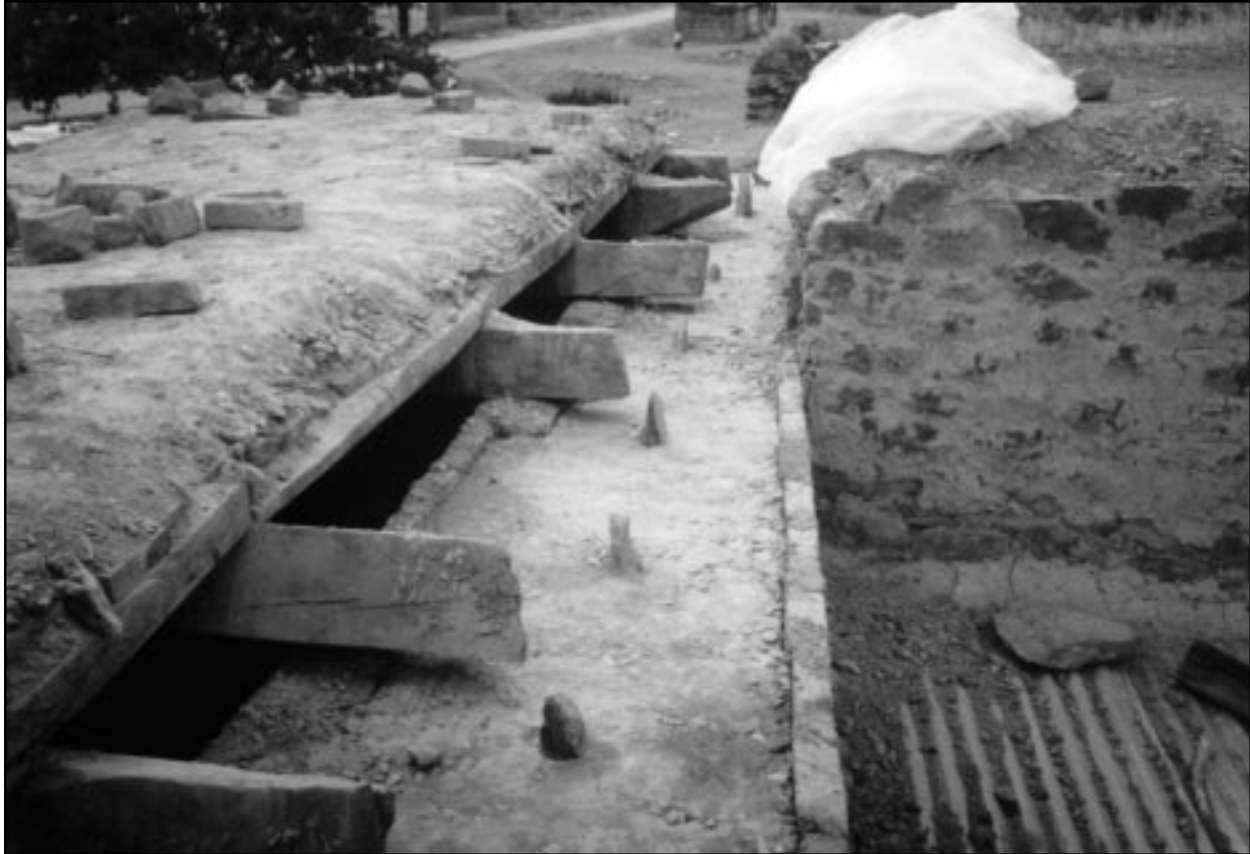
**Figure 21** An example of concrete band installation at the eaves level of a stone masonry wall.

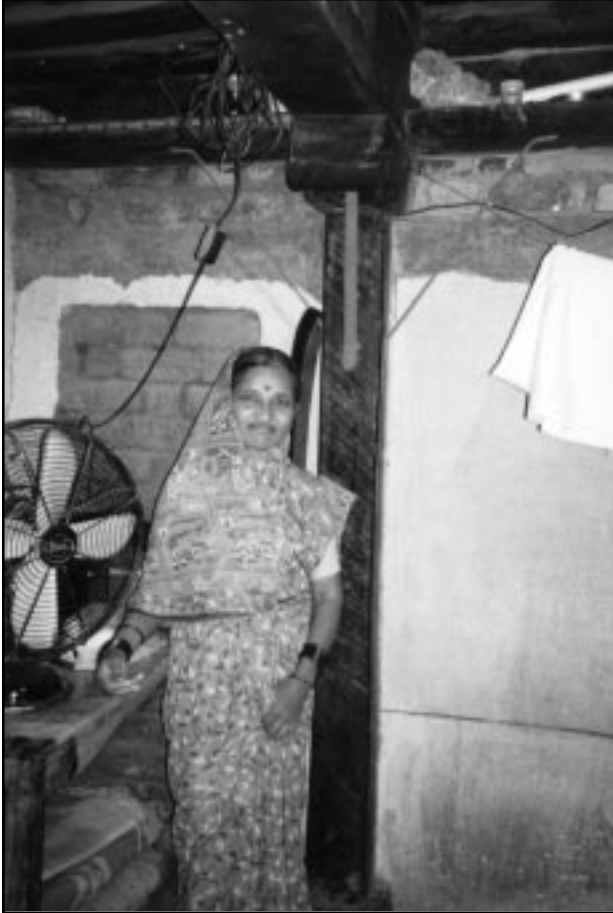
**Figure 22** A beneficiary of a rebuilt strengthened house where a timber frame was retrofitted with knee braces (steel angles).

- The existing heavy roofs were either removed and replaced with lighter structures or, alternatively, roof weight was considerably reduced by removing some of the heavy mud.
- Reinforced concrete bands (ring beams) were installed at the lintel and/or roof levels in order to preserve the integrity of the building in an earthquake and to minimize chances of an out-of-plane wall failure (Figure 21).
- Stone masonry walls were strengthened by providing through-wall anchors (through-stones) at certain predefined locations.
- Knee-braces were provided at the beam-to-post junctions to prevent the swaying of timber frames (Figure 22).

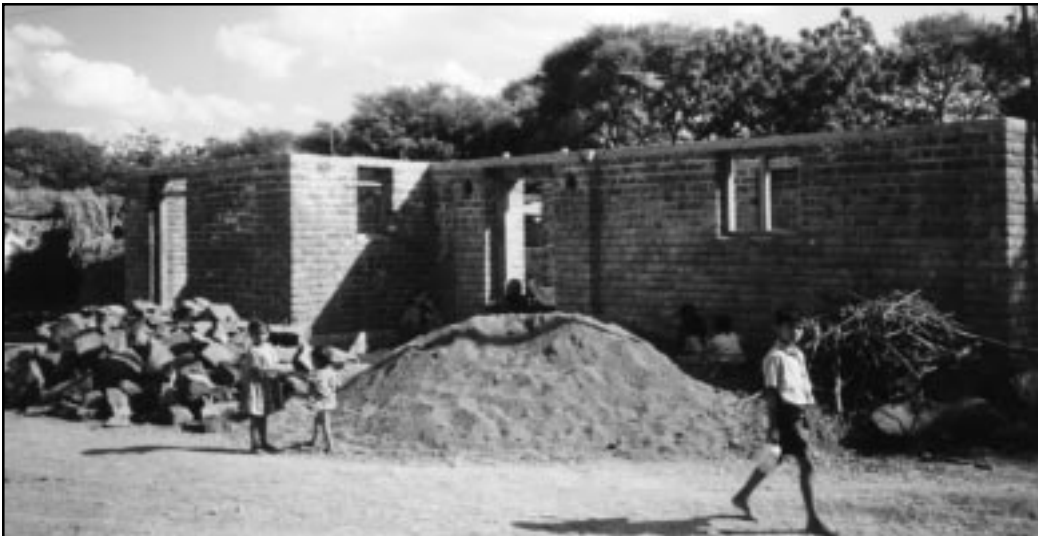
**Figure 23** A large majority of beneficiaries decided to dismantle their stone houses and carry out new construction in brick masonry.

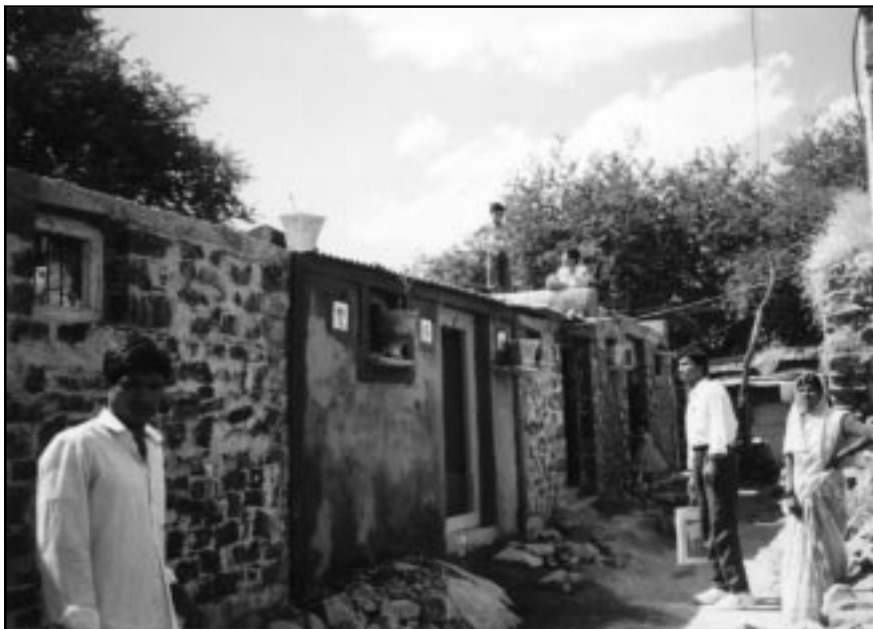
**Figure 24** In some villages, stone masonry remained the most popular building material after the earthquake. Here a Junior Engineer is inspecting several new stone masonry houses.

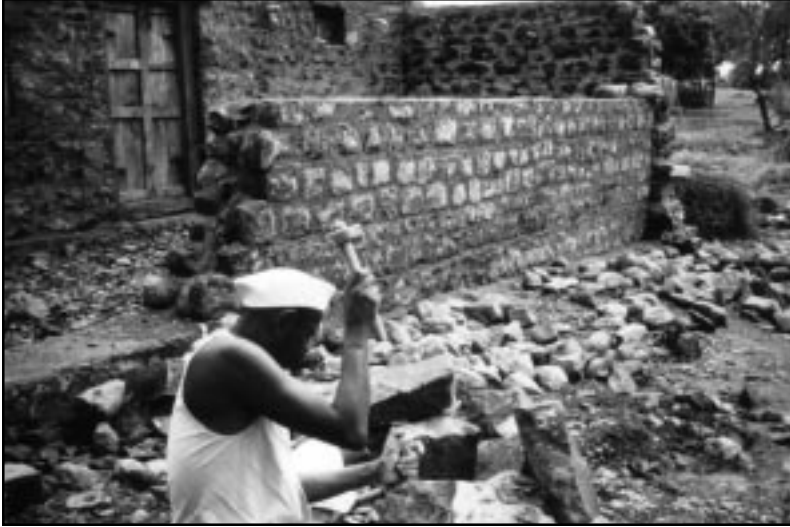
**Figure 25** New stone walls were constructed using shaped stones cut by stonecutter artisans.

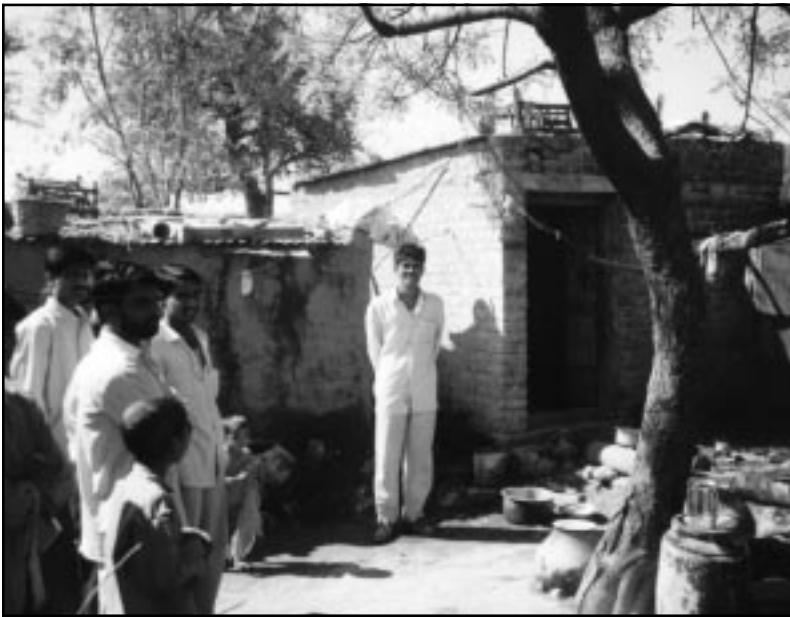
**Figure 26** New houses were constructed to much higher standards than the houses that were built before the earthquake. An old house (left) and a new house (right) are shown here, with the beneficiary standing in front of the new one.

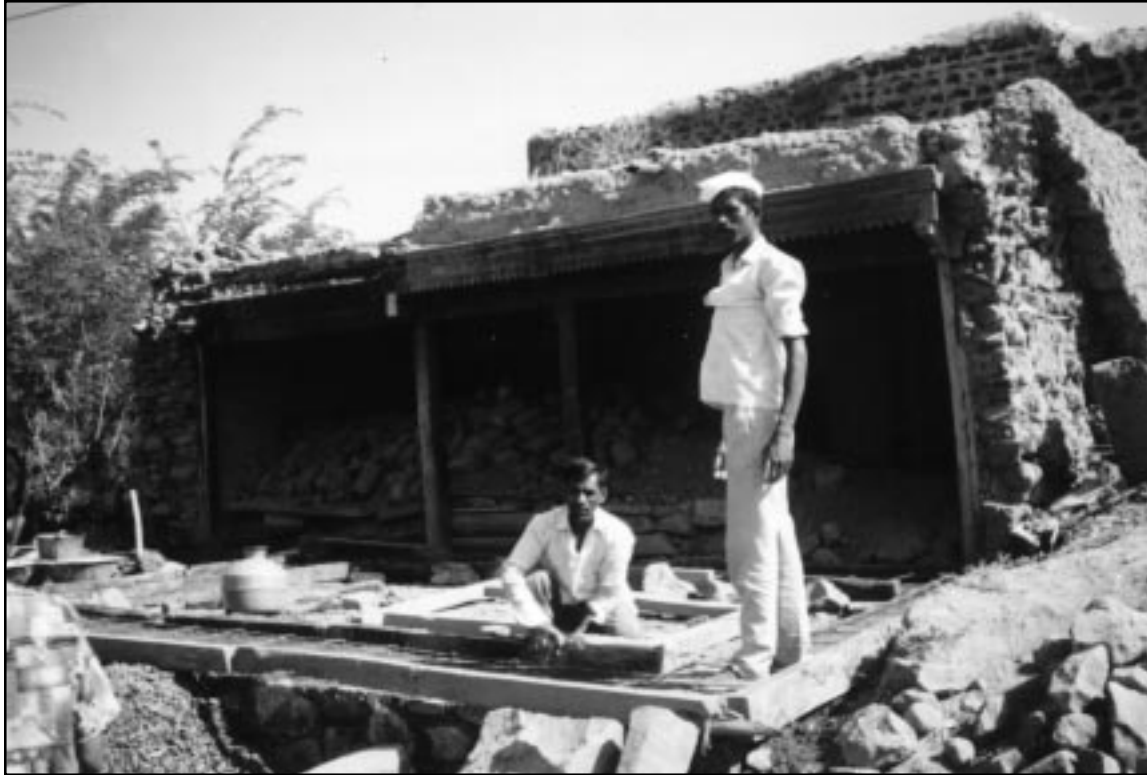
**Figure 27** An example of a situation where retrofitting was not a feasible option due to excessive wall thickness and poor quality of construction. Masons are shown constructing a new plinth band.

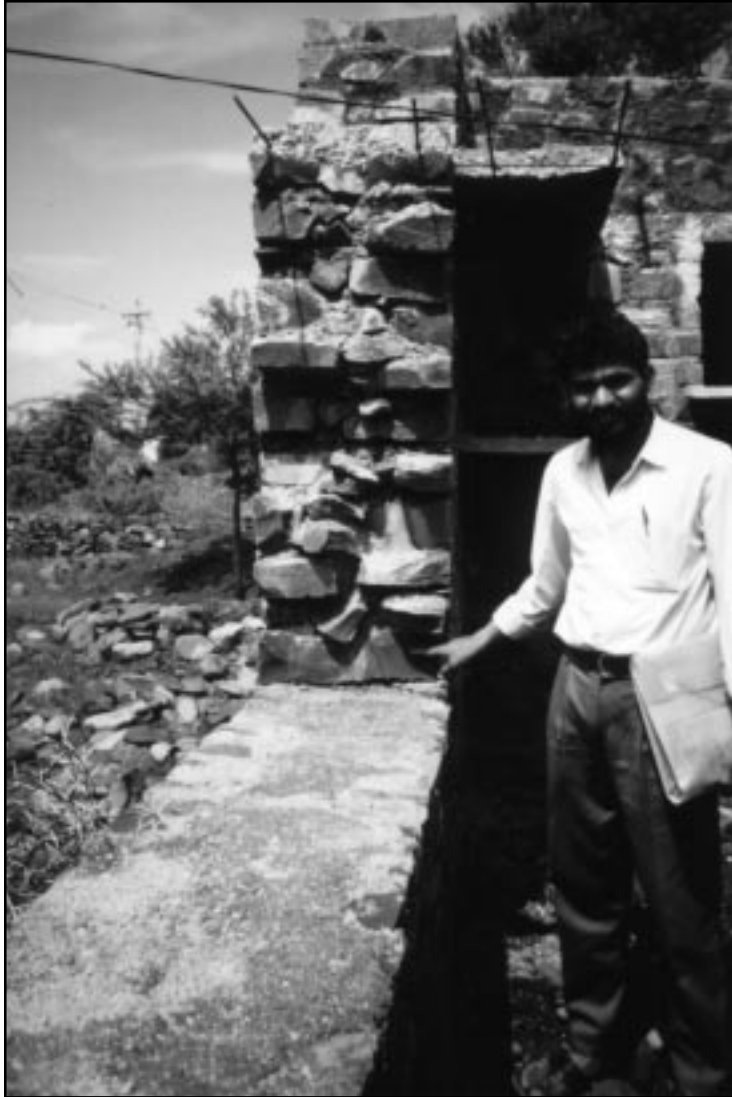
**Figure 29** A GOM Junior Engineer inspecting a newly built stone wall and pointing out a through-stone.

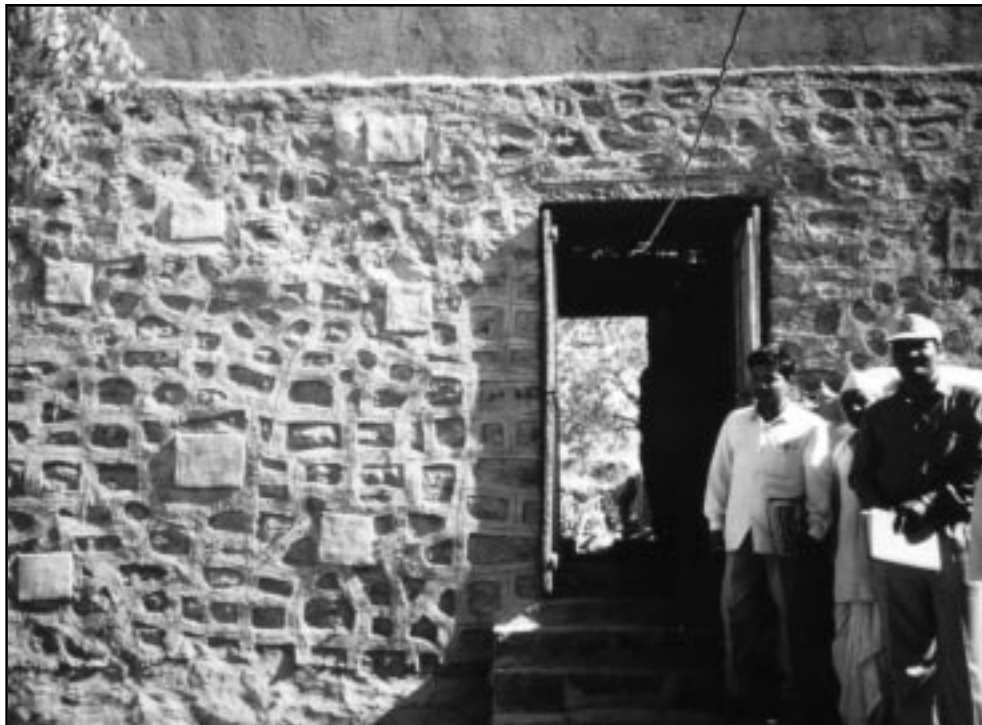
**Figure 30** Junior Engineers inspecting a retrofitted stone house that has through-stones and a roof band.

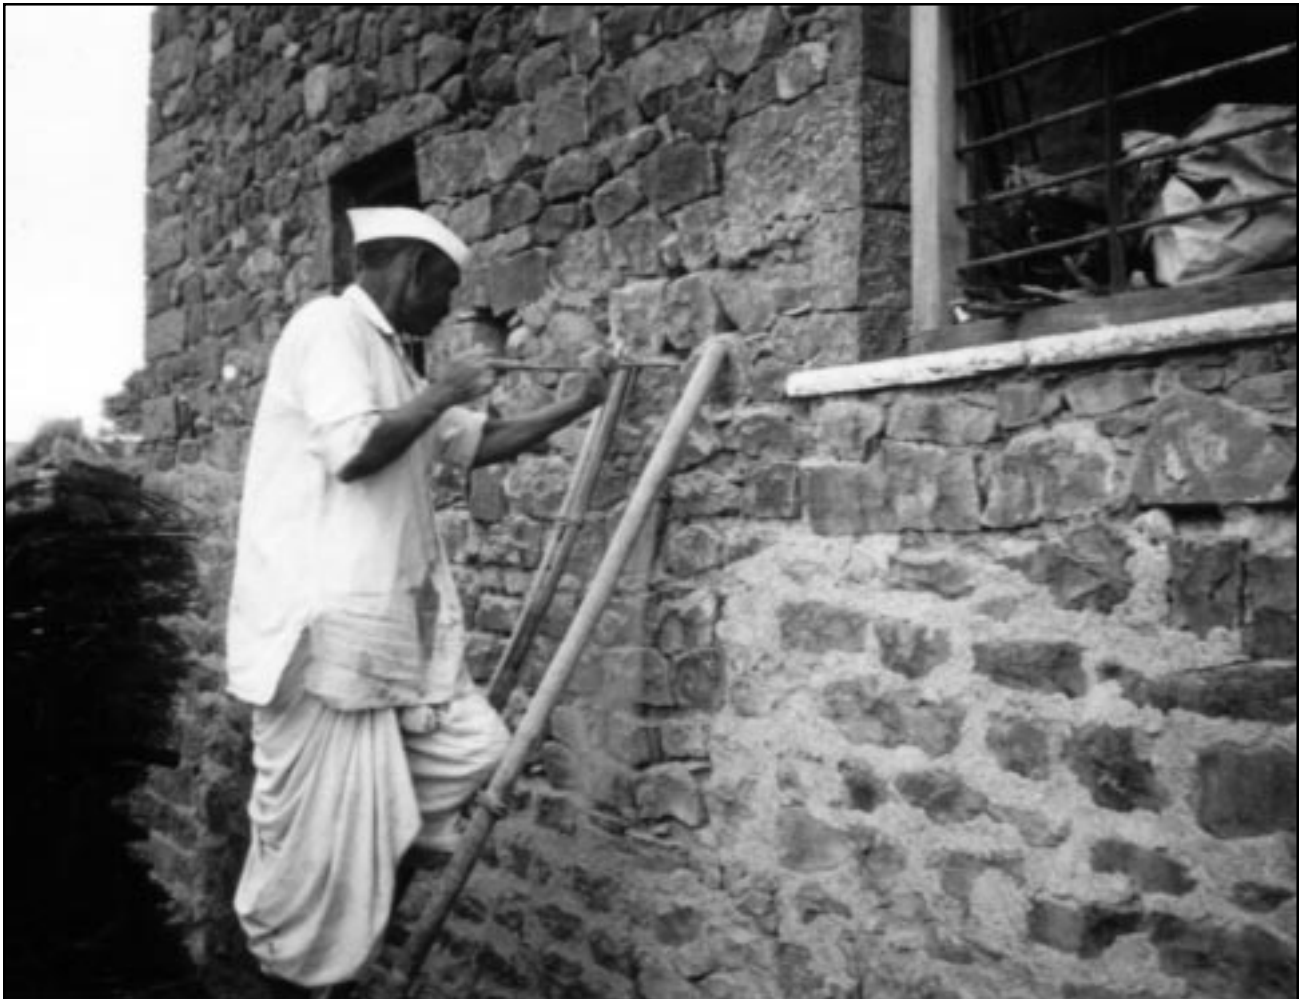
**Figure 32** A village artisan preparing to install a through-stone. Here, he is removing a stone with a crowbar.

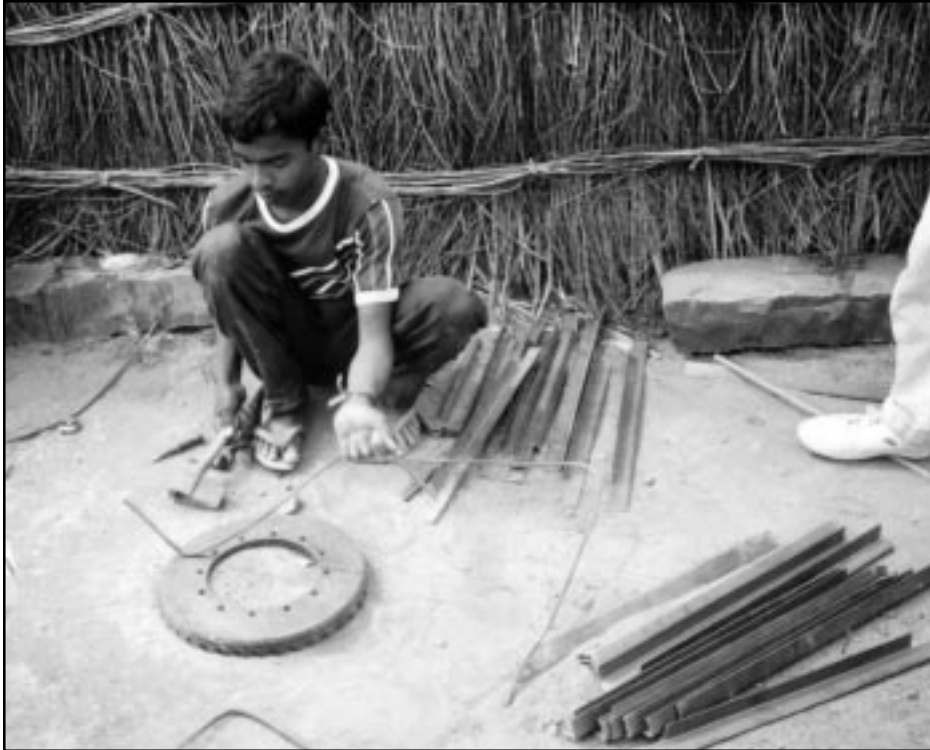
**Figure 33** A village artisan working on fabrication of steel hoops for seismic bands and knee-bracings (rolled steel angles at the right).

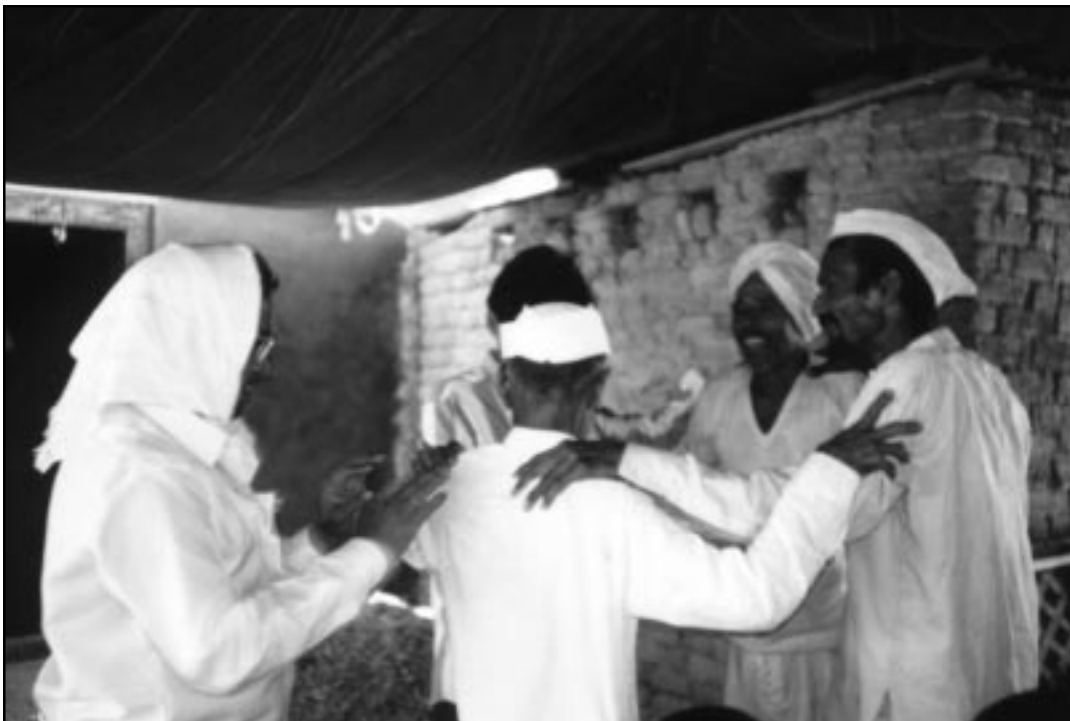
**Figure 34** A PMU Deputy Engineer (left, wearing a scarf) explains the concept of seismic band to traditional artisans (masons).

The JEs taught local artisans how to construct a seismic band, an important seismic feature very rarely found in the area before the earthquake. Thanks to the JEs, local artisans learned to bend steel reinforcement bars and manufacture kneebraces for the strengthening work (Figure 33). In addition to the JEs, their peers in the PMU, deputy engineers, executive engineers, superintending engineers, and chief engineers also visited the villages and provided guidance to the traditional artisans on a regular basis. Figure 34 shows a PMU deputy engineer (with a

scarf) explaining the concept of a seismic band to a homeowner and the masons. “If four persons are braced together (like a house with a seismic band), they become more resilient to the effect of a push than each of the four persons individually.”

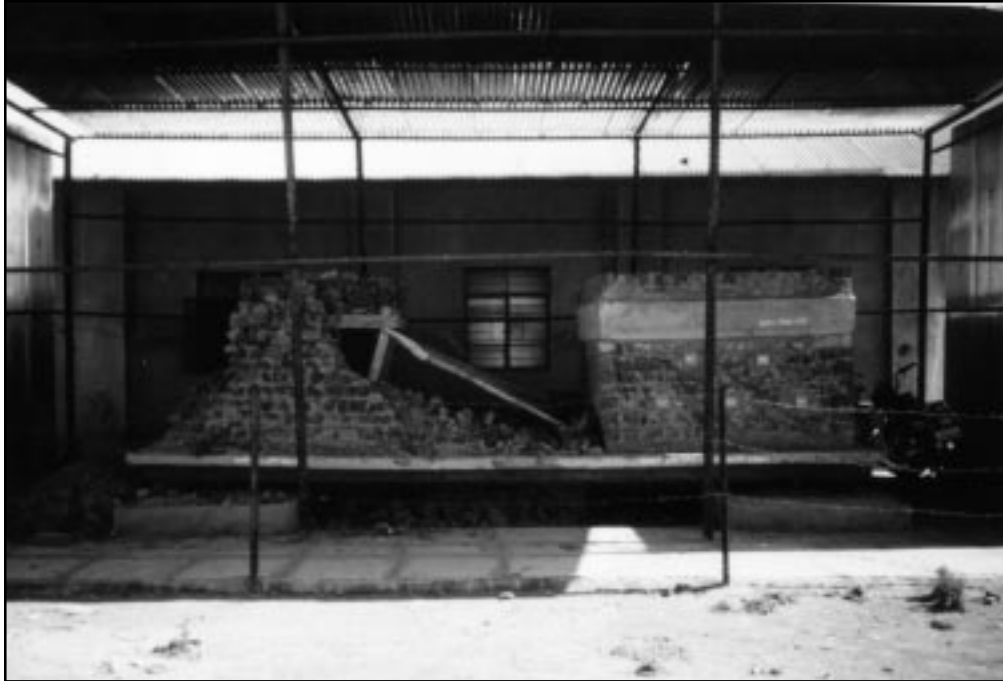
**Figure 35**  
*Experimental verification of the retrofitting technology at Umarga, Osmanabad district. A retrofitted model is shown at the right and the unstrengthened model (damaged) is shown on the left.*

- The strengthened specimen sustained the effects of all 12 shocks without collapse. The last shock was extremely severe, characterized by peak base (table) acceleration of 1.6g. The model developed only minor cracks in the shock characterized by a peak base acceleration of 0.47g. The extent of cracking increased in proportion to the intensity of impact loading, although collapse did not occur during the tests.

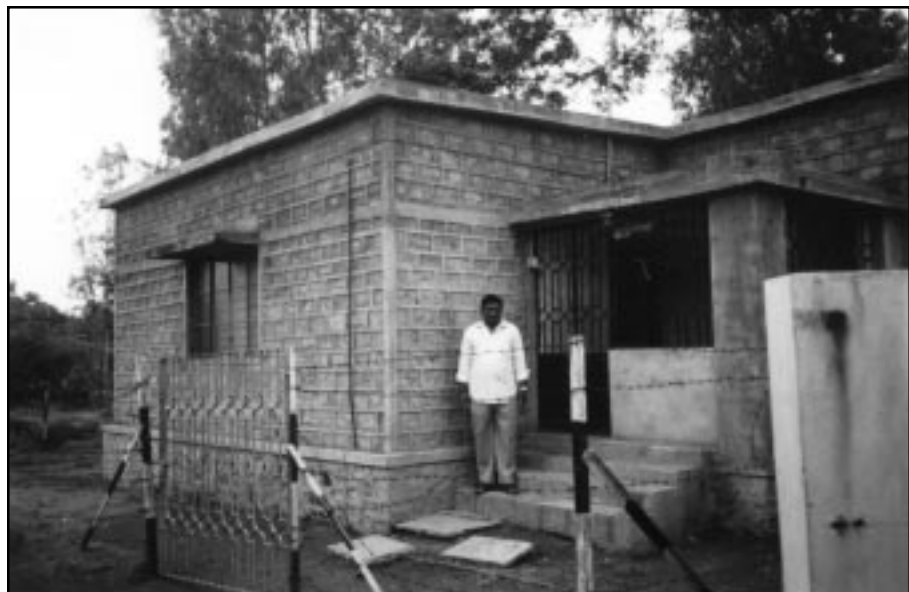
**Figure 36** A model house used as a residence of a PMU Deputy Engineer in Latur.

houses their official residences during the MEERP implementation since Indian government agencies provide official accommodations for their employees. In the Latur district, for example, the superintending engineer (the topmost GOM engineering position at a district level), and his subordinates (five executive engineers and over 20 deputy engineers) all resided in the stone masonry model houses (Figure 36). This gesture was an effective “confidence-building” tool for the many beneficiaries who feared stone construction. The model houses incorporated seismic features and were highlighted by bond beams that were painted in bright colors. Most model buildings were constructed at exposed locations. In front of some buildings there was a sign, written in the local Marathi language, which described the salient seismic features of that particular building.

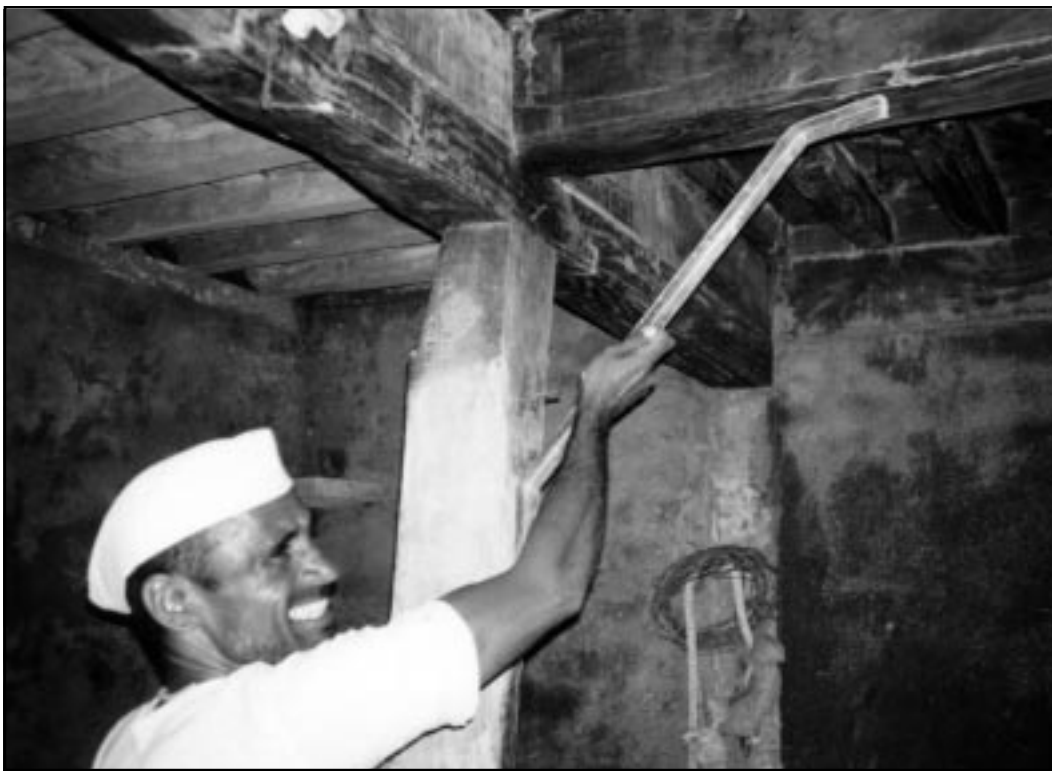
**Figure 37**  
*A beneficiary of the PSP showing a knee-brace used to retrofit a timber frame structure.*

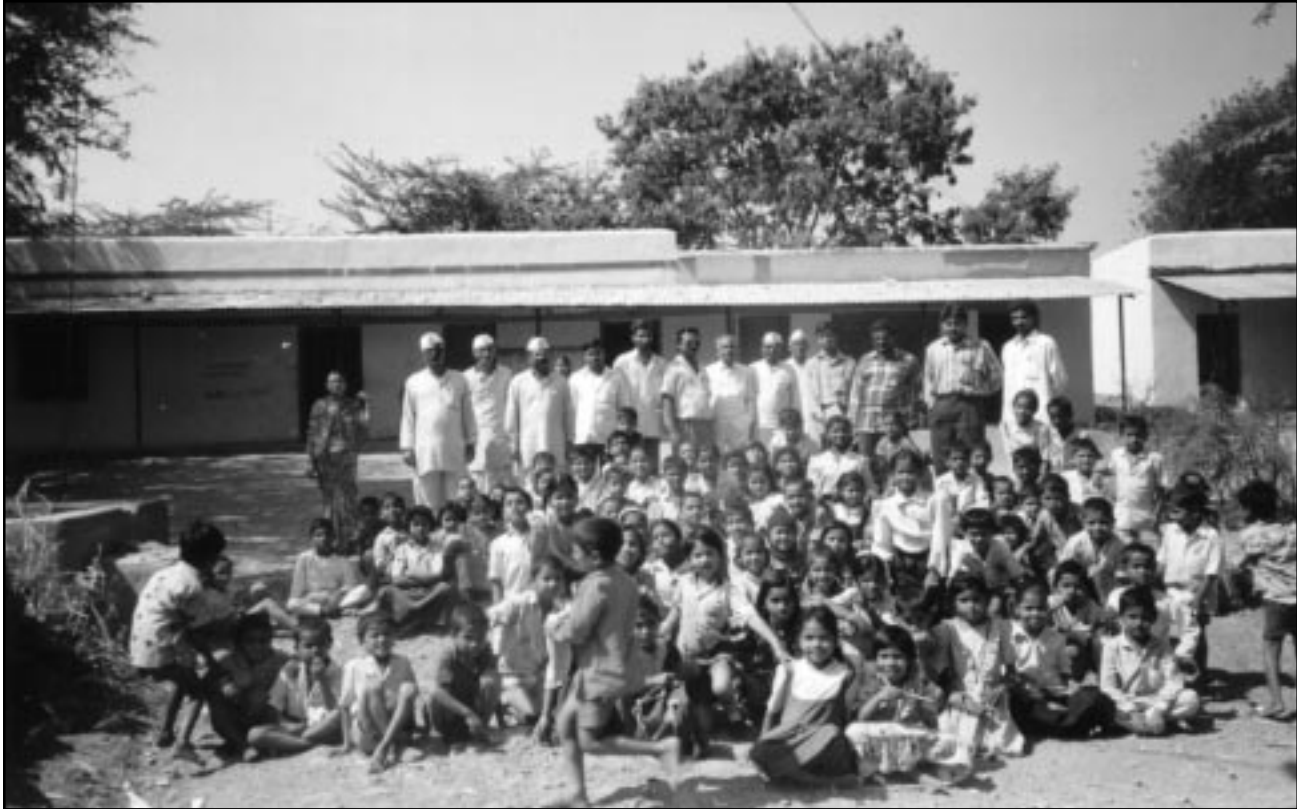
**Figure 39** Students and teachers in front of a retrofitted elementary school building in the Latur district. The concrete bands are dark stripes near the top of the buildings.

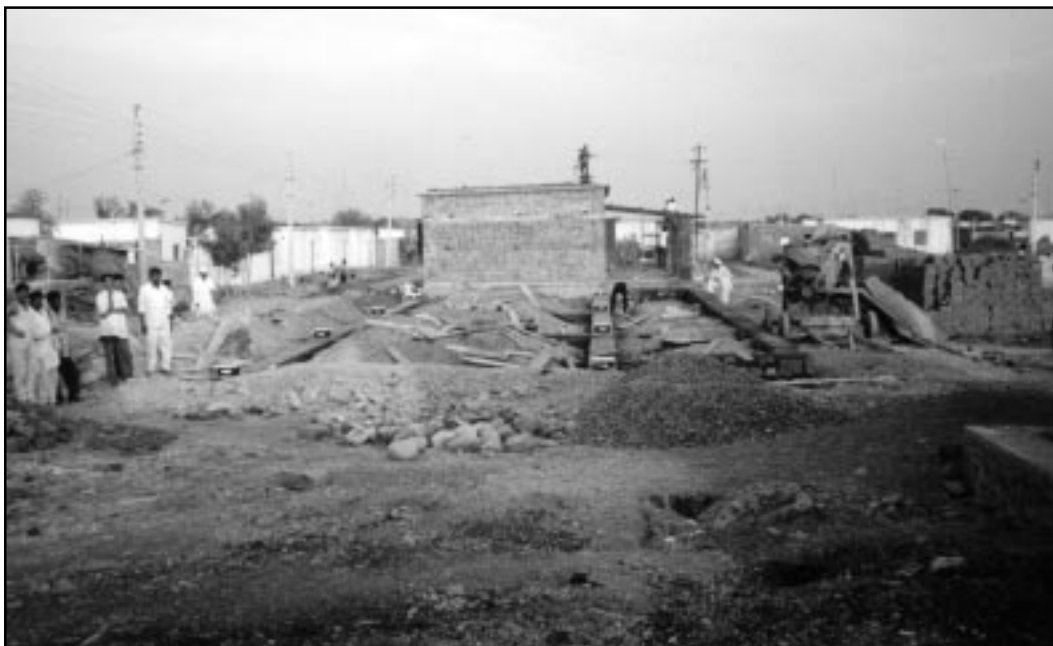
**Figure 40** A half portion of the Killari school building was constructed as a base-isolated structure (under construction in foreground), and the twin brick masonry building in the background was constructed in a conventional manner.

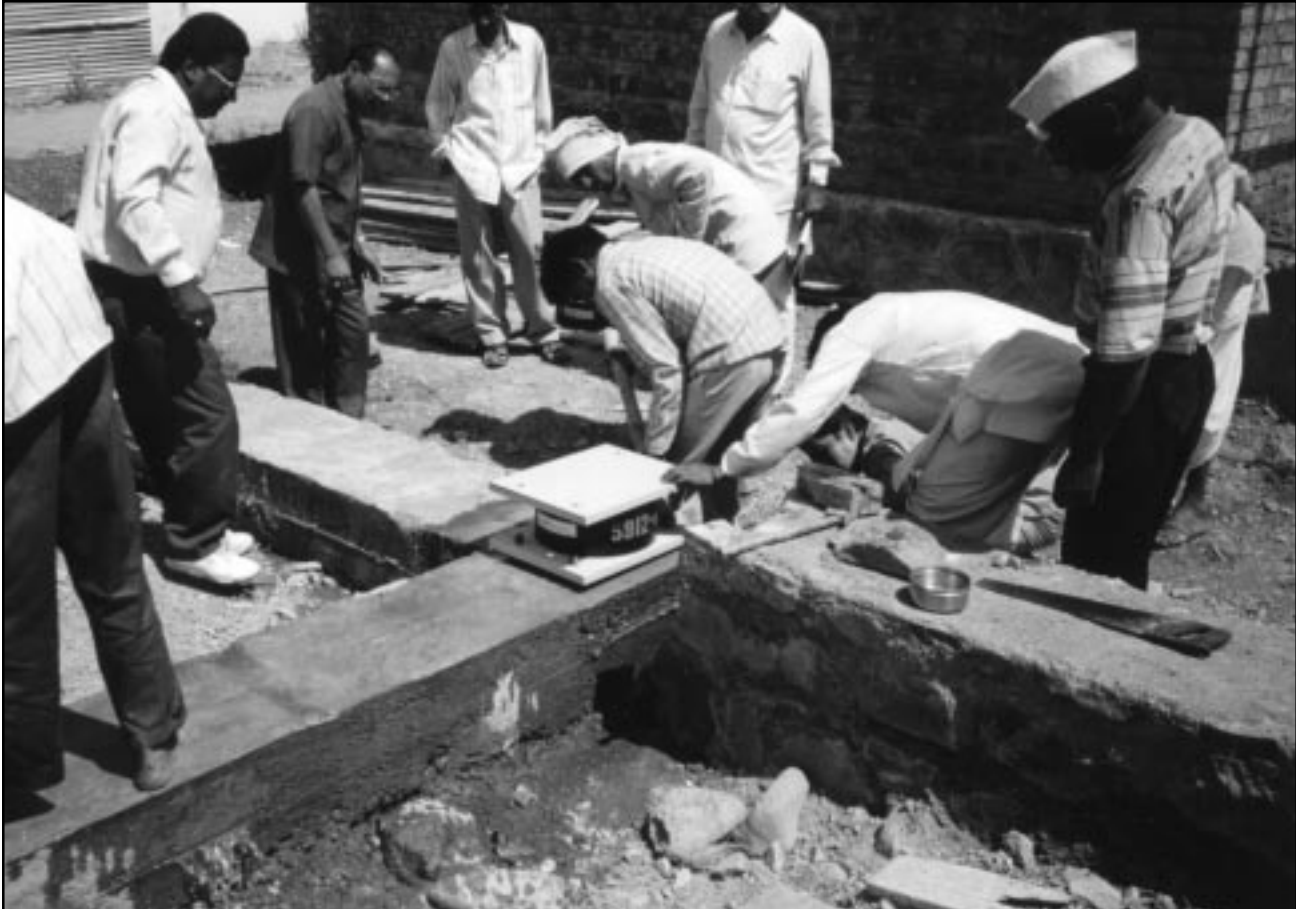
**Figure 41** Installation of isolation bearings carried out manually using local artisans under the supervision of PMU engineers.

The only additional construction features specific to the isolated structures were concrete ring beams installed below and above the isolation bearings (Figures 41 and 42). The isolation bearings were made of natural rubber reinforced with steel shims. A bolted connection was used to attach the bearings to the adjoining structures. Installation of the bearings was completed in February 1999. The installation was carried out manually, and the construction was done by the local construction work force (masons) with experience in masonry construction and without any previous exposure to complex engineering projects. The supervision during the construction was provided by the PMU engineers assisted by the foreign seismic consultant to the PMU.
