# Housing Reconstruction

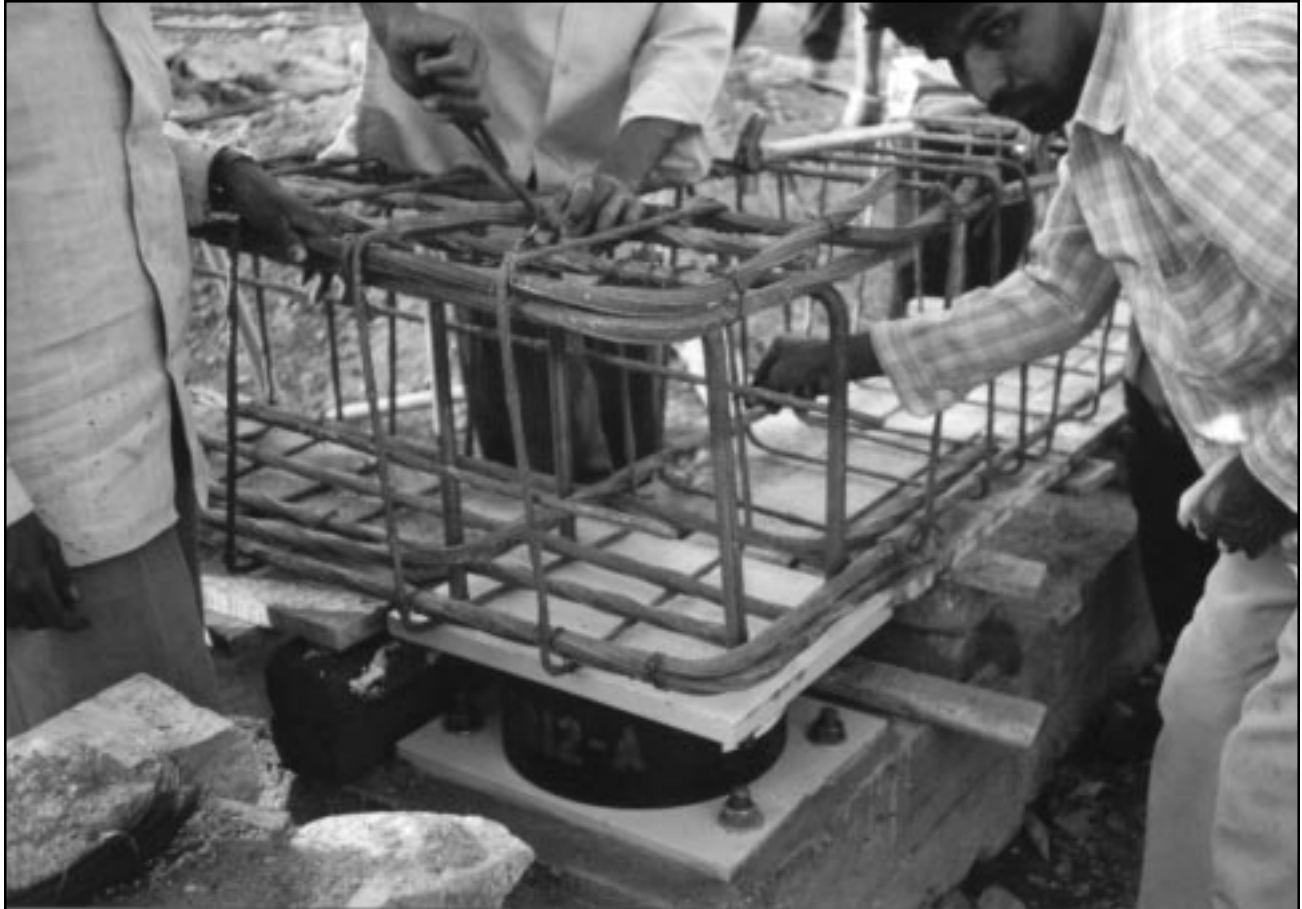
**Figure 42** Construction of an upper concrete ring beam above the isolators for a school building in Killari village.

The only additional construction features specific to the isolated structures were concrete ring beams installed below and above the isolation bearings (Figures 41 and 42). The isolation bearings were made of natural rubber reinforced with steel shims. A bolted connection was used to attach the bearings to the adjoining structures. Installation of the bearings was completed in February 1999. The installation was carried out manually, and the construction was done by the local construction work force (masons) with experience in masonry construction and without any previous exposure to complex engineering projects. The supervision during the construction was provided by the PMU engineers assisted by the foreign seismic consultant to the PMU.
