Learning from Earthquakes

The Great Sumatra Earthquake and Indian Ocean Tsunami of December 26, 2004

Report #3

The Effects in Mainland India and in the Andaman-Nicobar Islands

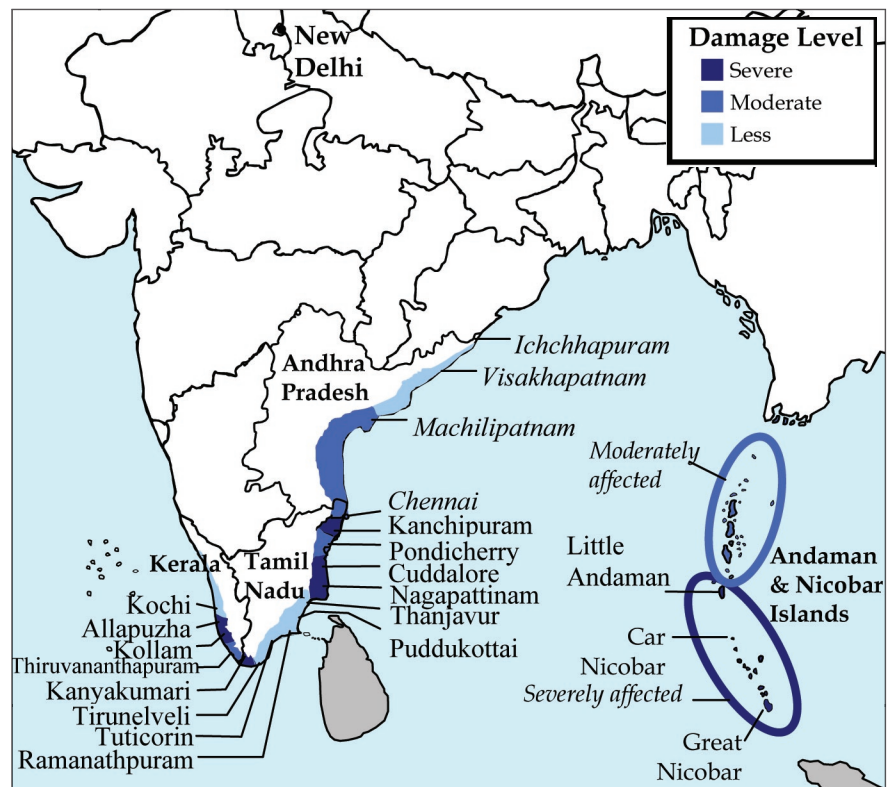
shaking (on the MSK scale) was VII; along the mainland Indian coast, it was V. The tsunami arrived in the A&N Islands between 40 and 50 minutes after the earthquake, with Port Blair recording its arrival at 7:15 a.m., and it caused extensive devastation of the built environment. The tsunami arrived in the states of Andhra Pradesh and Tamil Nadu along the southeast coast of the Indian mainland shortly after 09:00 a.m. At least two hours later, it arrived in the state of Kerala along the southwest coast. Tamil Nadu and Kerala were extensively damaged, while Andhra Pradesh sustained moderate damage (Figure 1).

Figure 1. Map showing relative tsunami-induced damage along the coastal districts (in mainland) and in the islands (in A&N Islands).

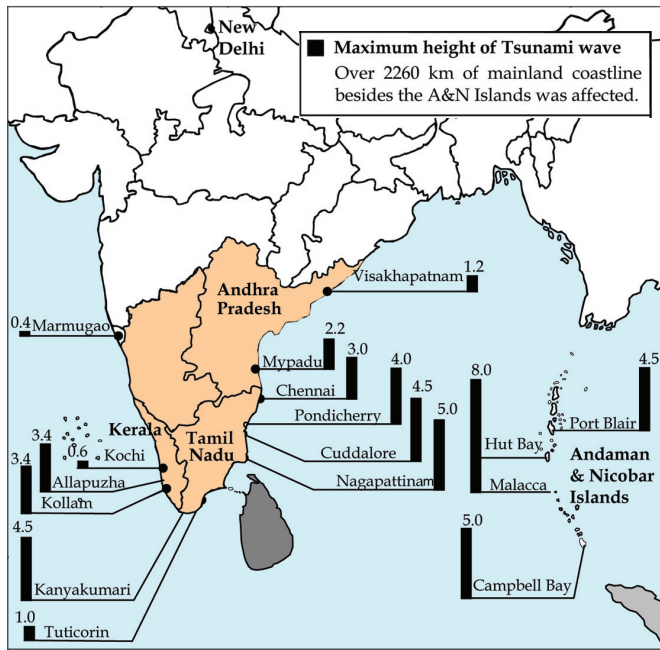
Figure 13 shows variations in run-up height along the coast. It was only 1.6 m in areas in the state of Tamil Nadu that were shielded by the island of Sri Lanka, but was 4-5 m in coastal districts such as Nagapattinam in Tamil Nadu that were directly across from Sumatra. On the western coast, the runup elevations were 4.5 m at Kanyakumari District in Tamil Nadu, and 3.4 m each at Kollam and Ernakulam Districts in Kerala. Some of these amplitudes are based on eyewitness accounts and may be subjective. The time lapse between the waves also varied from about 15 minutes to about 90 minutes.

Figure 13. Maximum tsunami wave heights at various locations. The vertical bar indicates the amplitude of wave height and the number indicates the value in meters.
