Background

The Earthquake

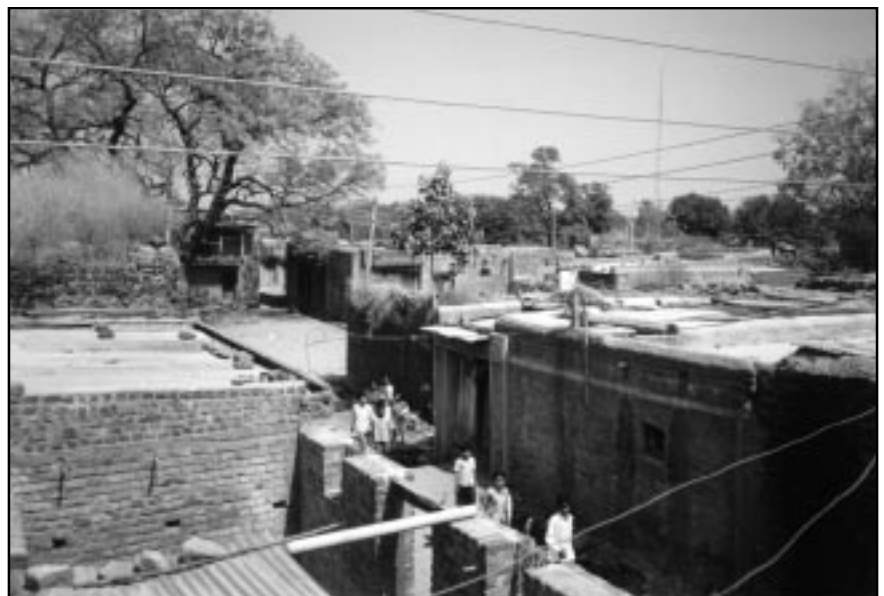
Figure 4 The typical densely built village, consisting of clusters of houses, provided very limited opportunity for horizontal extensions.

The typical villages of the affected area were generally old and had an almost medieval urban form: the so-called gaothans (village residential sections) were compact and densely built (Figure 4), and they frequently featured monumental, arched gateways. The abutting stone masonry walls of houses delineated narrow, winding streets, rarely wider than 3 m (10 ft.), just enough to allow for the passage of bullock carts. House fronts had very few openings, since for security reasons the houses were inward-oriented. A high plinth was used on almost all the houses, giving them a monumental appearance (World Bank, 1993).

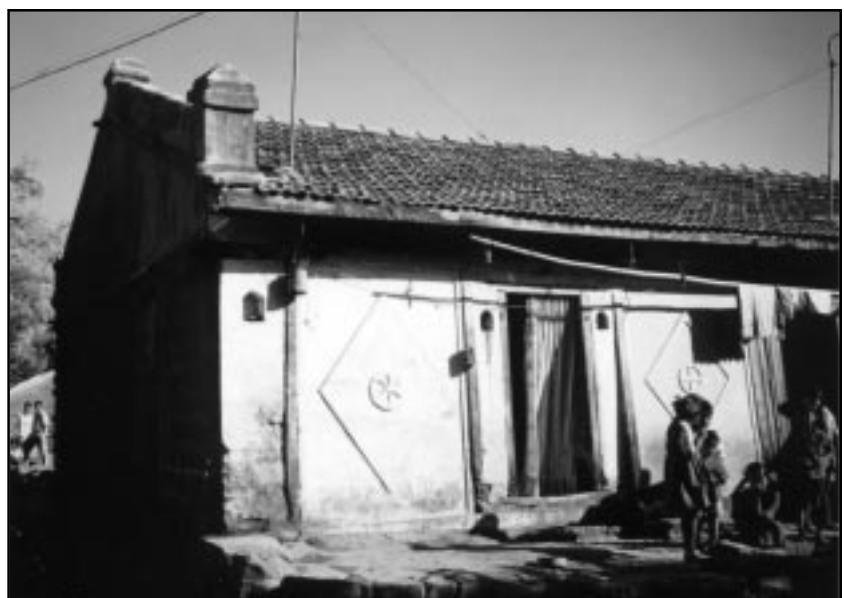
Traditional rural houses in the high rainfall areas of Maharashtra (Satara, Sangli, Pune, Kohlapur districts) are characterized by sloped timber roofs covered with clay tiles (Figure 6). The core area of such a house typically consists of two rooms, enclosed by a verandah on all four sides.

Figure 6 A typical house with a sloped timber roof covered in clay tile in the high rainfall area of Maharashtra.
